# Safety Alert

**ARTC No. 121**  
**Issued 11/03/2020**

## Toyota Landcruiser Wheel Inspections

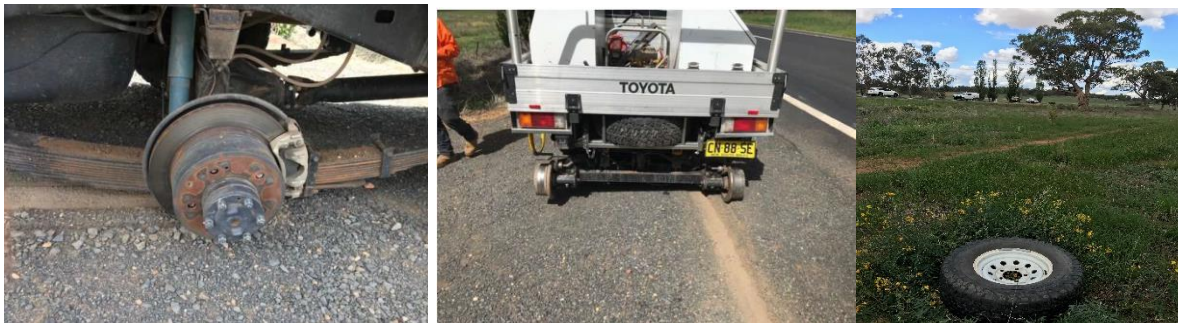
This alert has been issued following an incident where a wheel separated from an ARTC Toyota Landcruiser road rail vehicle (RRV) which was travelling at 110 km/h.

During the investigation it was found that the 5-wheel studs have sheared on the right-hand rear wheel.

Further investigation has revealed a similar vehicle was found to have wheel nuts which were over-tensioned. Early indications are that this may have contributed to this incident.

As a precautionary measure we are requesting all Toyota Landcruisers (both RRV and non RRV's) have the tensioning of wheel nuts checked to ensure they meet manufacturers specified torque settings.

1. Place Safety Alert on display and make copies of this alert available to people who report to you (without regular email access) and ensure that the contents of the safety alert are discussed/explained to your staff.
2. All Area Managers to ensure all Landcruiser's (both RRV and non RRV's) are checked by either your local Toyota servicing agent or authorised LeasePlan tyre provider to remove road wheels, inspect wheel nuts, inspect wheel studs (inspection only, no requirement to remove or replace unless damaged), wheel rims (including wheel nut seat) and tyres for possible wear prior to re-tensioning wheel nuts to manufacturer specifications. If issues are located please engage with the fleet team.
