**TITLE/SUBJECT:**

Struck by Mobile Plant (FSR 05) and Crushed by a Crane or Lifted Load (FSR 08)

Type: Dangerous occurrence

Date Published: 27/03/2023

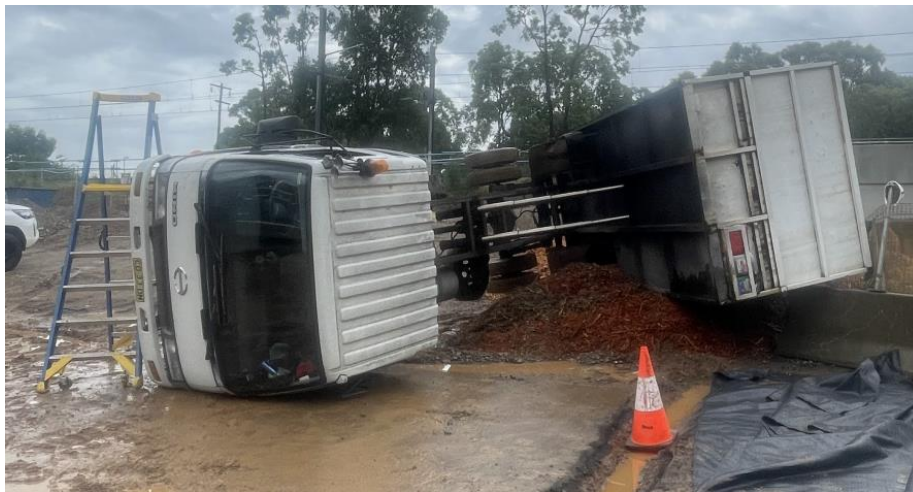
On 14 March 2023, a medium rigid tipper truck delivering woodchip mulch was unloading within the designated laydown area next to an existing stockpile of woodchip mulch. As the truck began to tip the load, some mulch

remained stuck within the enclosed back of the truck raising the centre of gravity of the truck and causing it to overbalance and roll onto the passenger side. The ground was found to be firm, however the rear axle was on uneven ground at the time. The driver was unharmed.

Cabramatta Loop Project – truck delivering woodchip mulch rolled onto passenger side.
