**ARTC**

**SJ23-0631-RPT-V1**

**Benalla Signal Hut  
Building Inspection Report**

**1<sup>st</sup> September 2023**

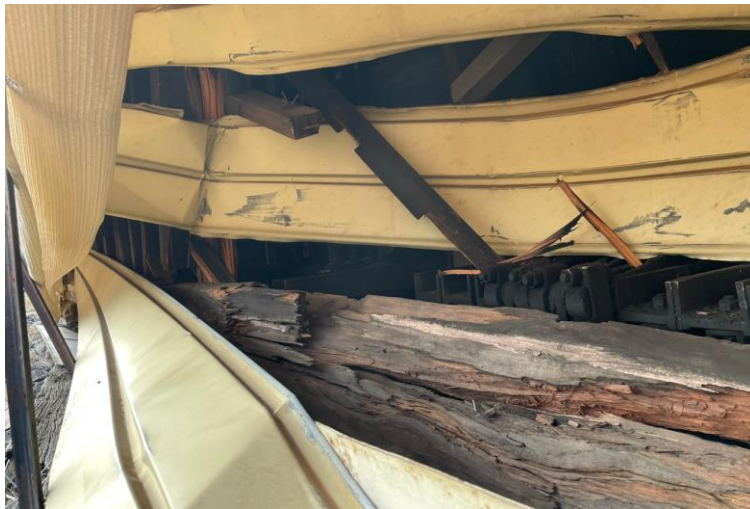
*Figure 3-5: Section of external cladding that has been damaged beyond repair.*

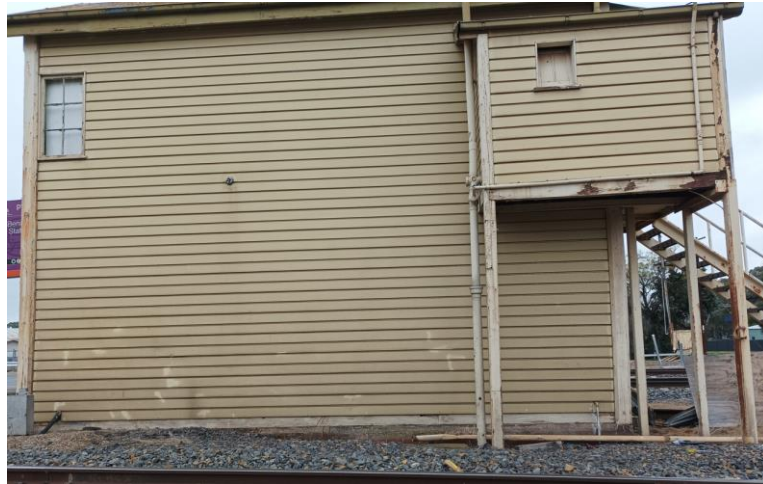
*Figure 3-6: General condition of steel weatherboard cladding*

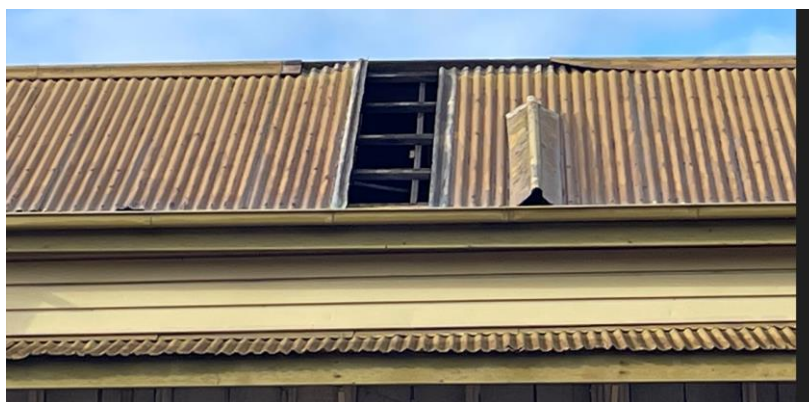
Figure 3-8: Section of roof sheeting missing and section of the roof ridge on top of the roof

The loose ridge capping poses an extreme safety hazard due to risk of it falling either onto the adjacent railway track or onto a pedestrian. **Due to the risk of the roof sheeting falling laterally or getting blown in the wind onto one of the adjacent railway tracks, the sections of the roof that are completely disconnected should be retrieved as soon as possible to prevent any collision with passing trains.**

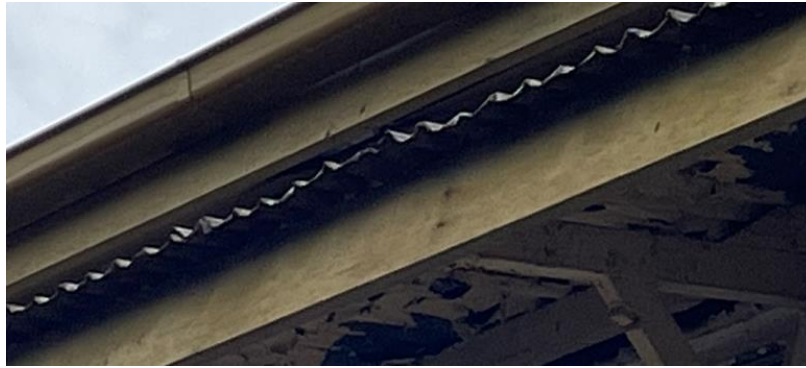
Figure 3-9: Deformed section of the roof sheeting on the lower portion of the roof

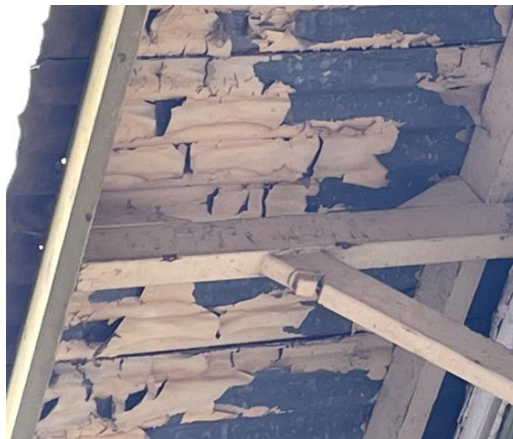
Figure 3-10: Deterioration of protective coating system on roof sheeting

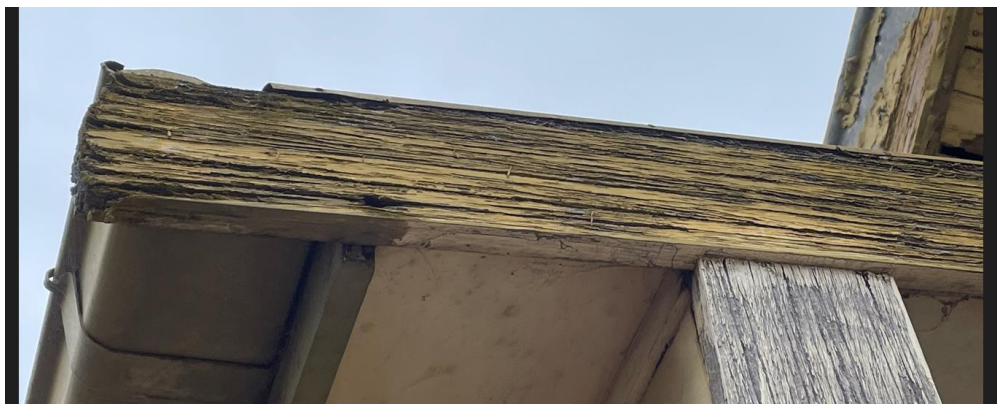
*Figure 3-11: Significant splitting and deterioration of the fascia member*

Certain sections of the timber fascia pose a safety hazard due to their instability and risk of disconnection. For this reason an exclusion zone is required to be set up to prevent pedestrian access. Due to the risk of the gutter or fascia falling laterally the exclusion zone should be erected several meters away from the building line. Given the location of the signal hut with respect to the live railway tracks, further provisions should be made to ensure that no debris falls onto the tracks and causes disruption to any passing trains.

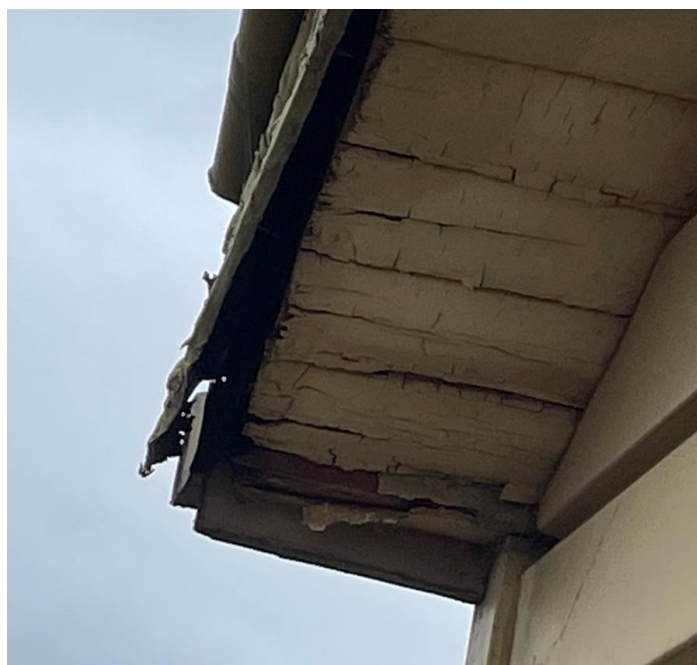
*Figure 3-12: Disconnected fascia member and deterioration of the roof lining*

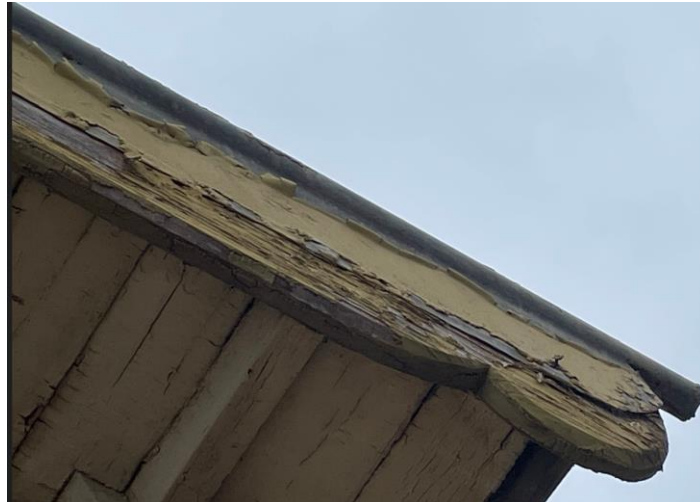
*Figure 3-13: Deteriorated fascia member*

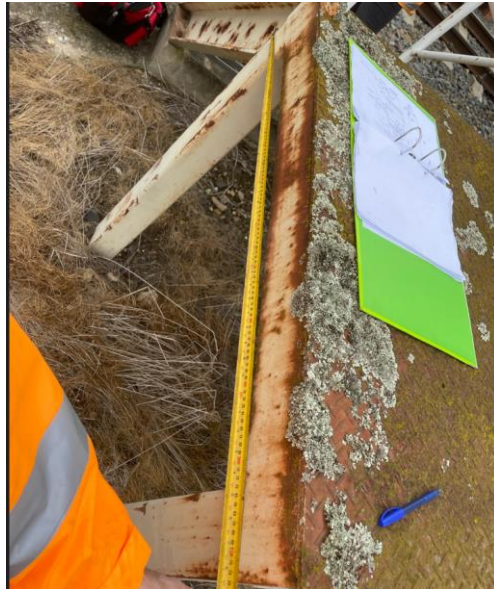
*Figure 3-14: General surface corrosion on one of the PFC members of the external staircase*

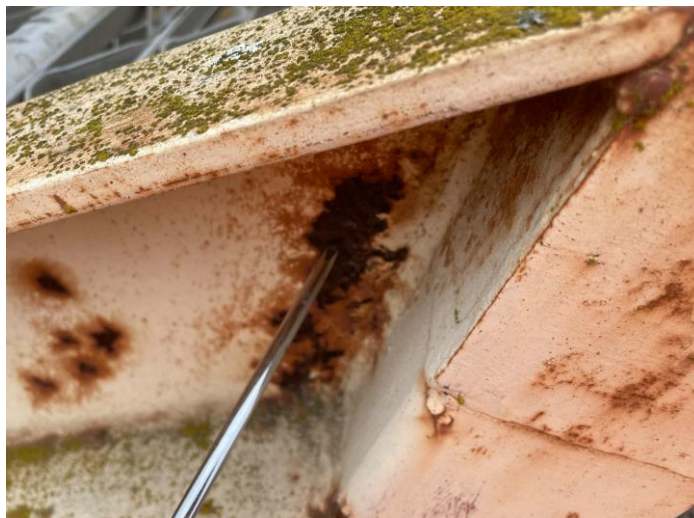
*Figure 3-15: Pitting corrosion on one of the PFC members on the external staircase*

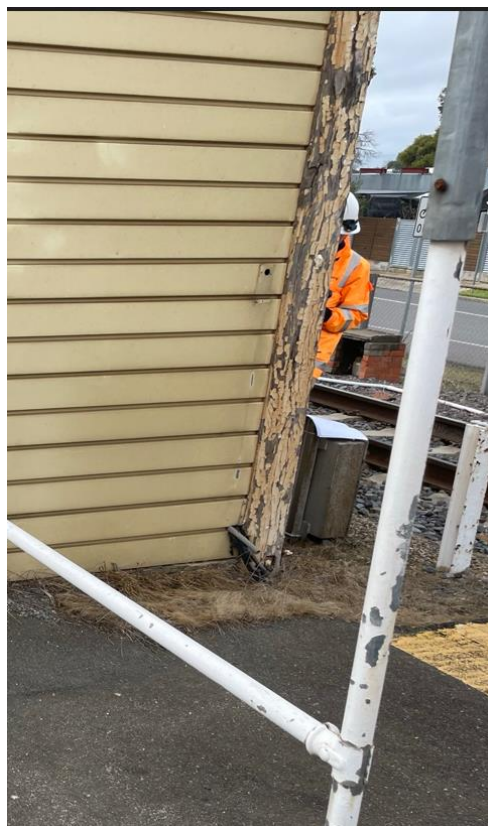
The column located at the south-west of the structure was severely split, indicating compromised structural integrity. Furthermore, there was notable deterioration in its protective coating system, leaving it vulnerable to further degradation. Similarly, the column situated at the north-west of the structure exhibited similar defects as previously mentioned, with additional damage caused by the vehicle collision impact on the north face of the building.

*Figure 3-16: Severe splitting and deterioration of protective coating system on south-west column*

The severe splitting and impact damage to the columns at the west side of the structure have reduced the column section capacity significantly and it is considered unlikely that these columns would retain sufficient capacity to comply with the design loads of the current Australian Standards.

Rectification would involve temporary propping works to ensure the signal hut remains stable during extraction and replacement of adversely affected column segments.

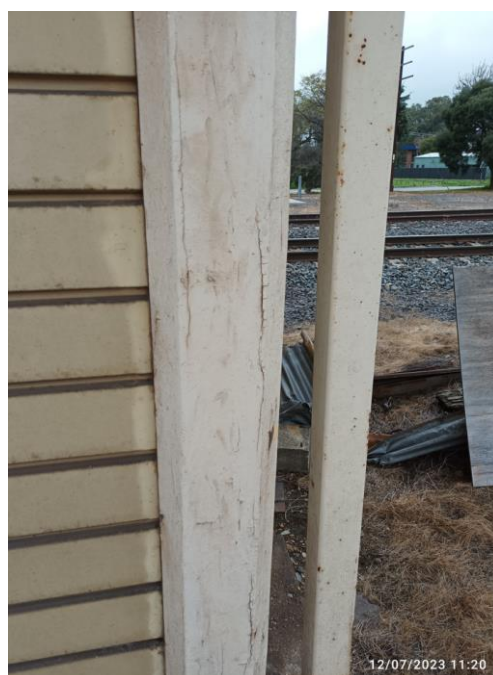
*Figure 3-17: General photo of main column on the south-east corner of the building*

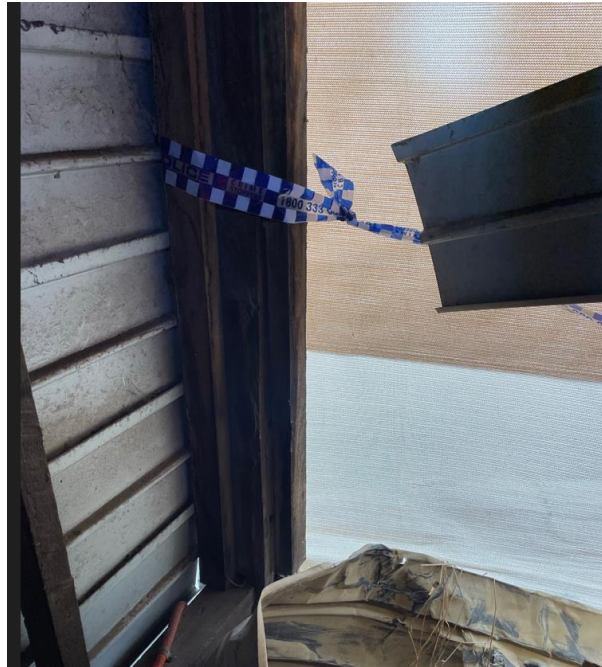
*Figure 3-18: Main column impacted by the accidental impact load*

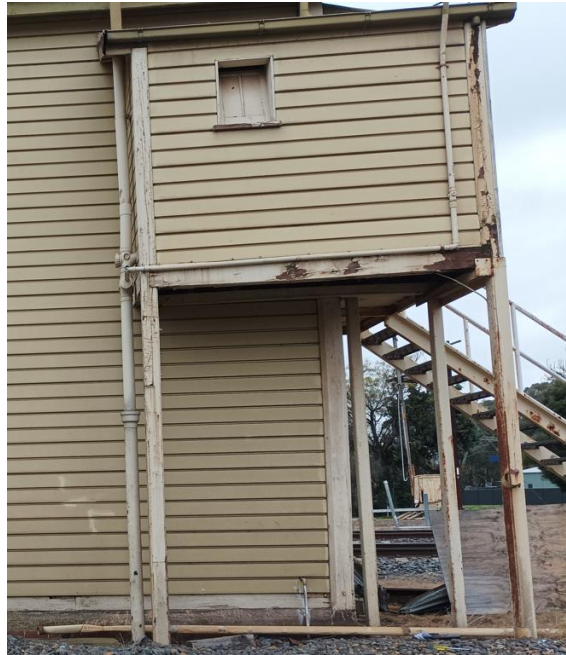
*Figure 3-19: Non horizontal external beam supporting first floor toilet*

The reduced structural capacity of the external beams in the signal hut raises significant concerns regarding the vulnerability of the associated first-floor area to potential structural failure. To rectify this issue, temporary propping works would be required to ensure the stability of the signal hut during the extraction and replacement of the affected beam segments. However, the cost and complexity of this work are substantial, involving the expertise of structural engineers and temporary works specialists. Additionally, the proximity of the structure to the rail track presents challenges in ensuring the safe execution of the works.

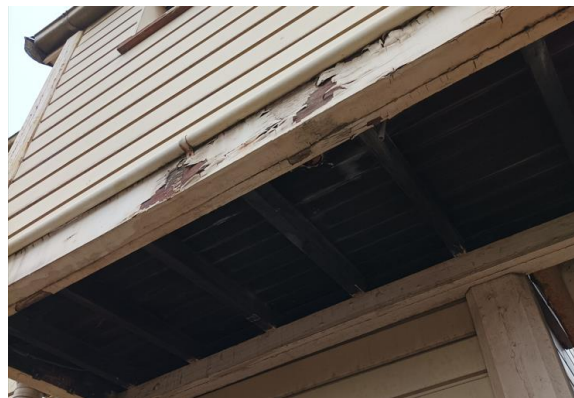
*Figure 3-20: Split in external beam supporting first floor toilet*

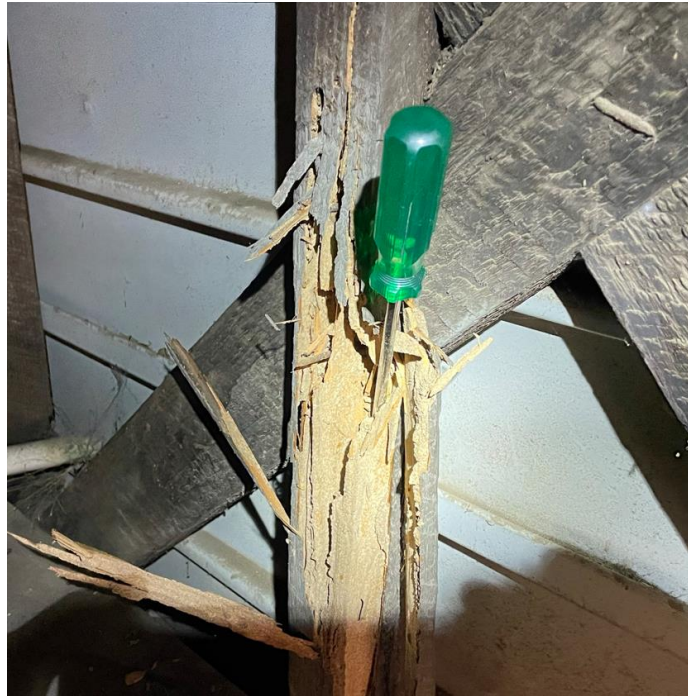
*Figure 3-21: Structurally failed member due to the possible presence of termites*

The current condition of the internal wall members, having been impacted by a vehicle, poses a risk to the signal hut's stability. Furthermore, the structural failure of one member due to possible termite presence suggests that other members may also be affected. Rectification measures would involve temporary propping works to ensure the stability of the signal hut during the extraction and replacement of adversely affected segments. Moreover, the proximity of the structure to the rail track presents a significant challenge to ensure safe execution of the works.

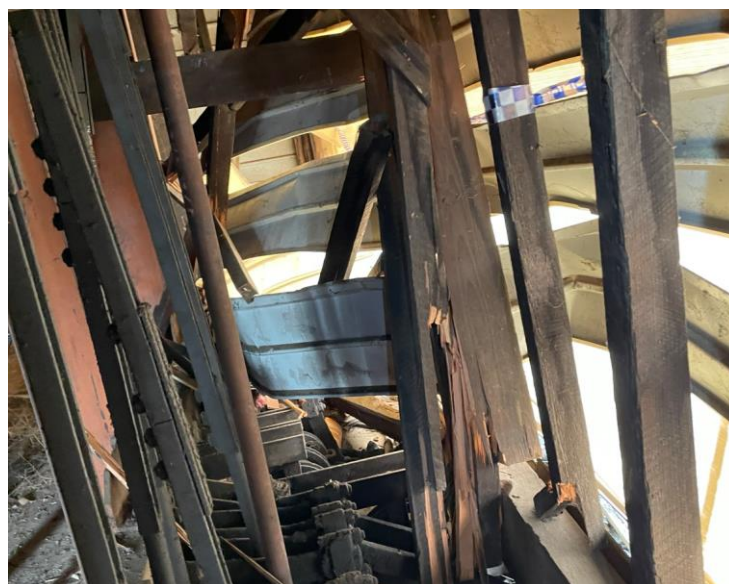
*Figure 3-22: Structurally failed column and mullions due to impact collision*

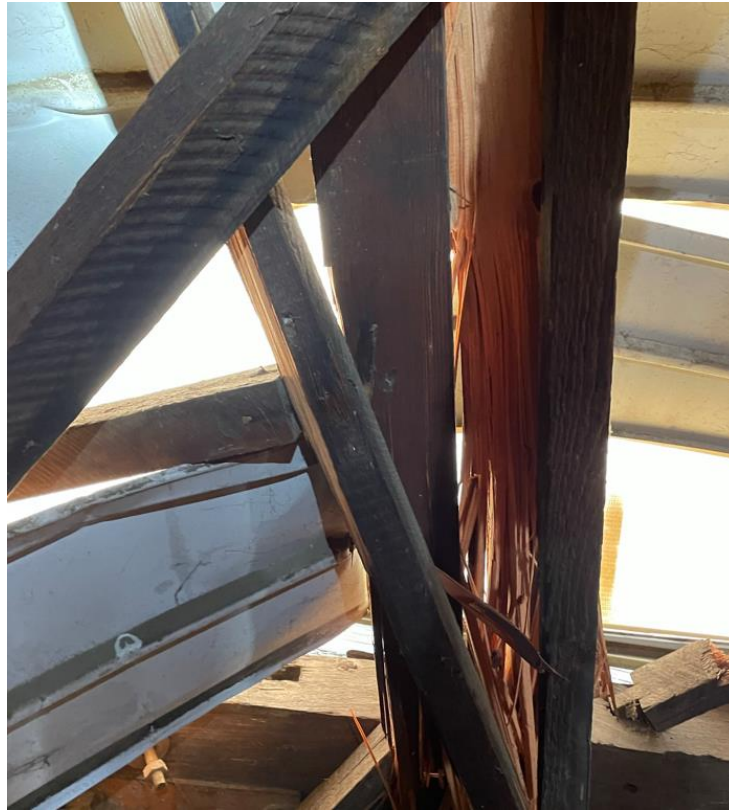
*Figure 3-23: Structurally failed column due to impact collision*

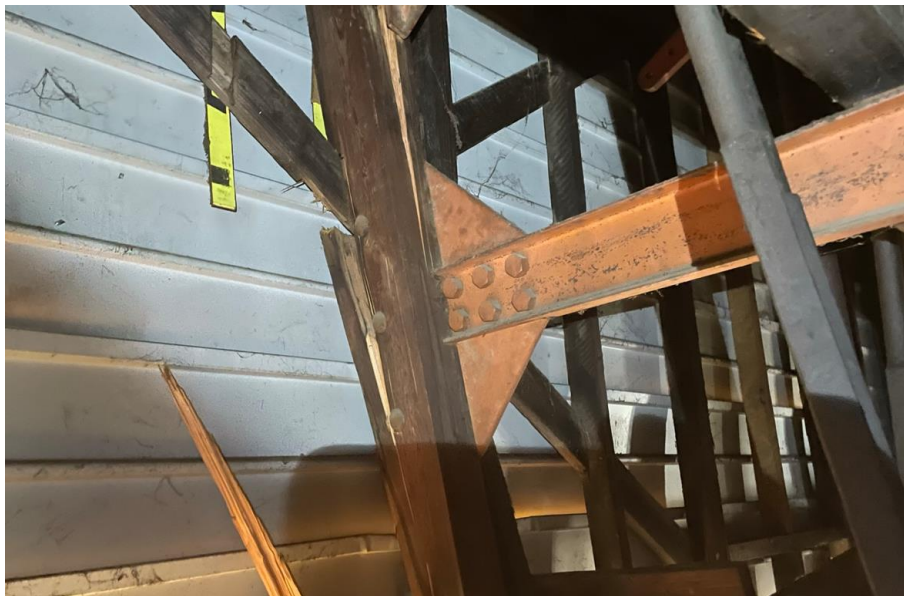
*Figure 3-24 Structurally failed members due to impact collision*

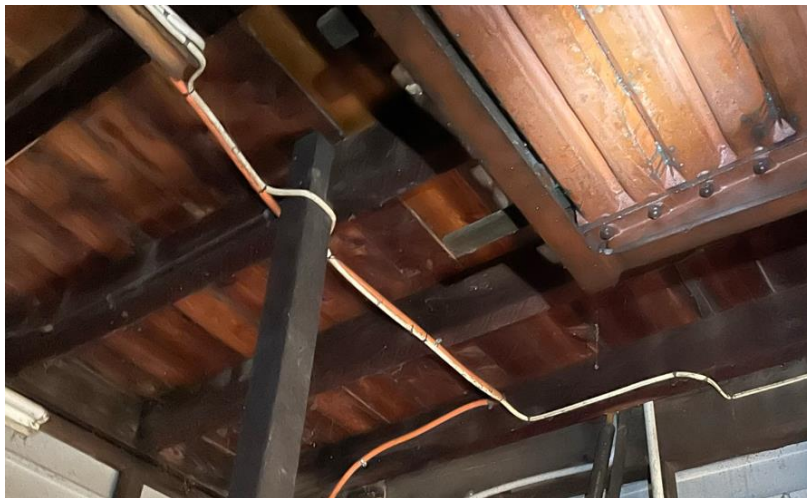
*Figure 3-25: Underside of timber beams and deck flooring of the first floor*

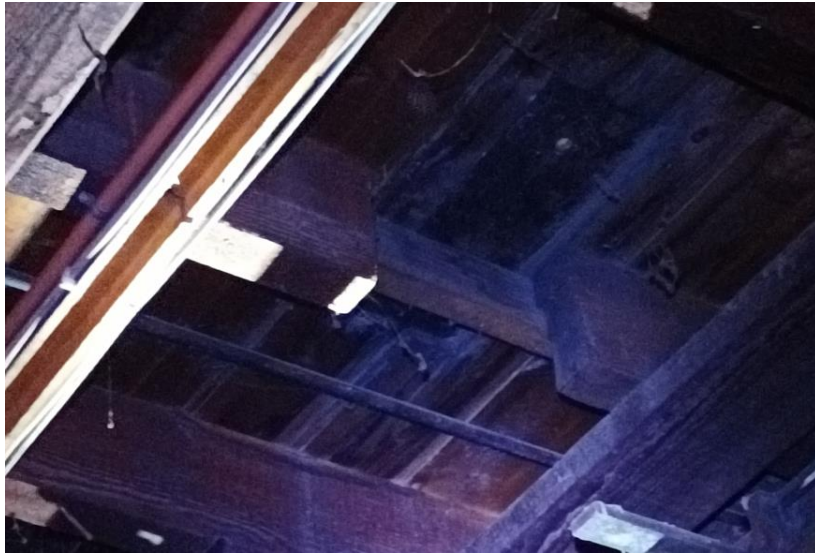
*Figure 3-26: Missing middle section of timber beam of first floor*

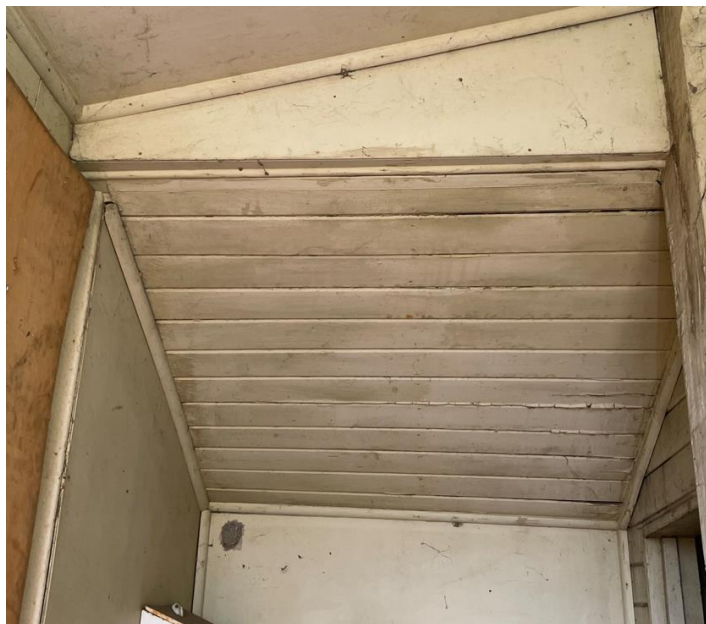
*Figure 3-27: Timber ceiling adjacent to first floor toilet*

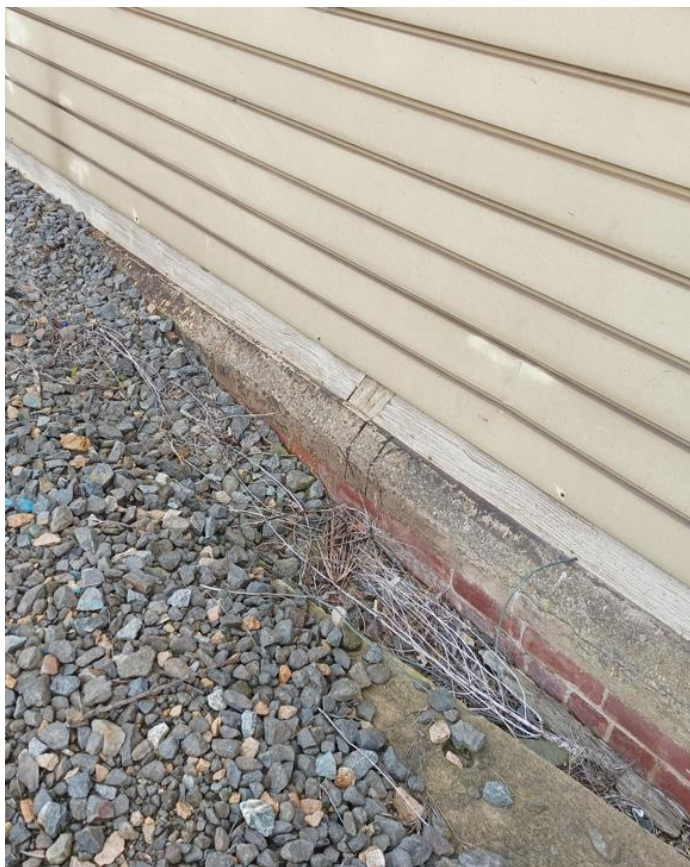
*Figure 3-31: General photo of concrete footing on masonry bricks*

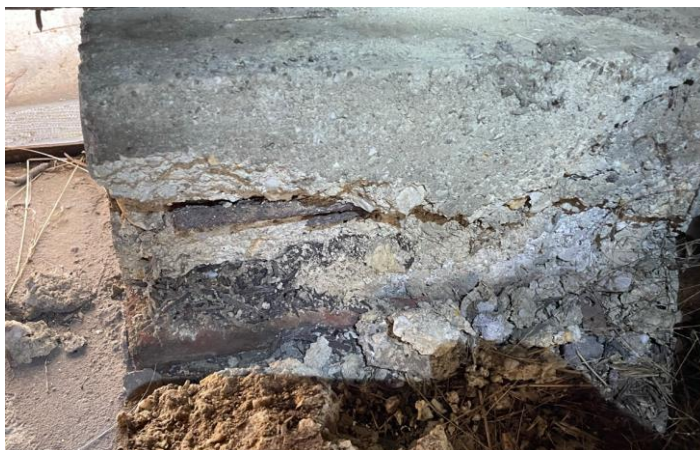
*Figure 3-32: Missing piece of the concrete footing*

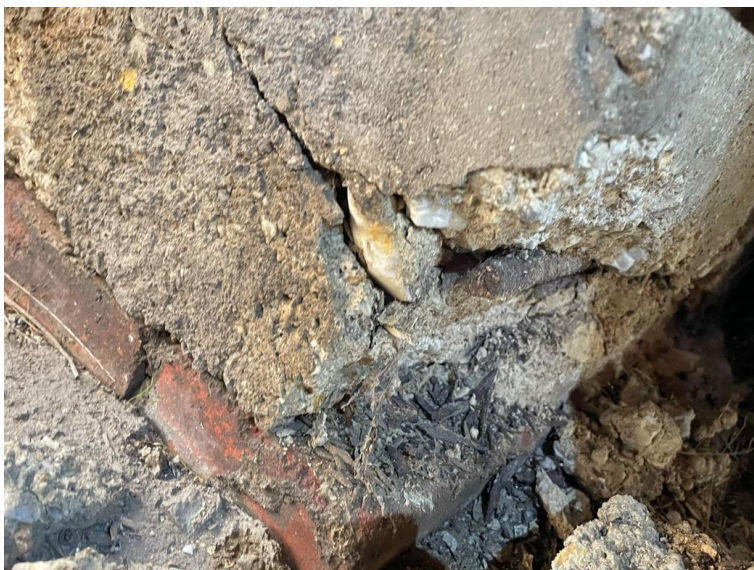
*Figure 3-33: Cracked piece of concrete upstand with exposed rebar*

Based on the findings of the inspection, an engineering judgement has been made, and it is not recommended to repurpose any of the concrete and masonry upstands from the existing signal hut and these should be appropriately recycled.

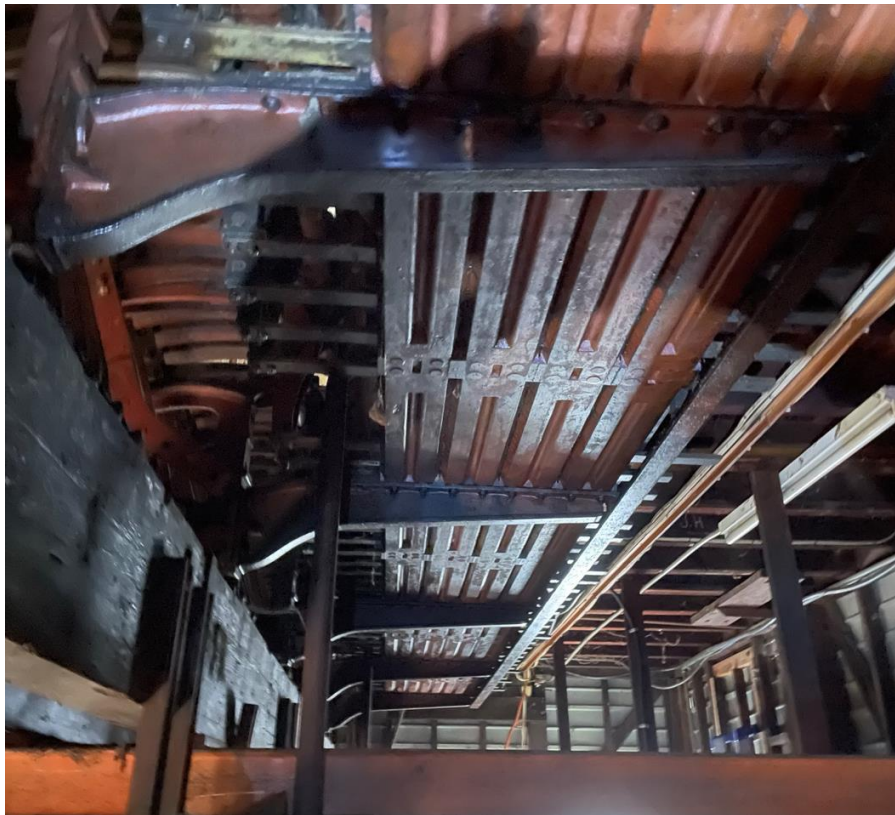
*Figure 3-34: Signalling lever frame and associated equipment*

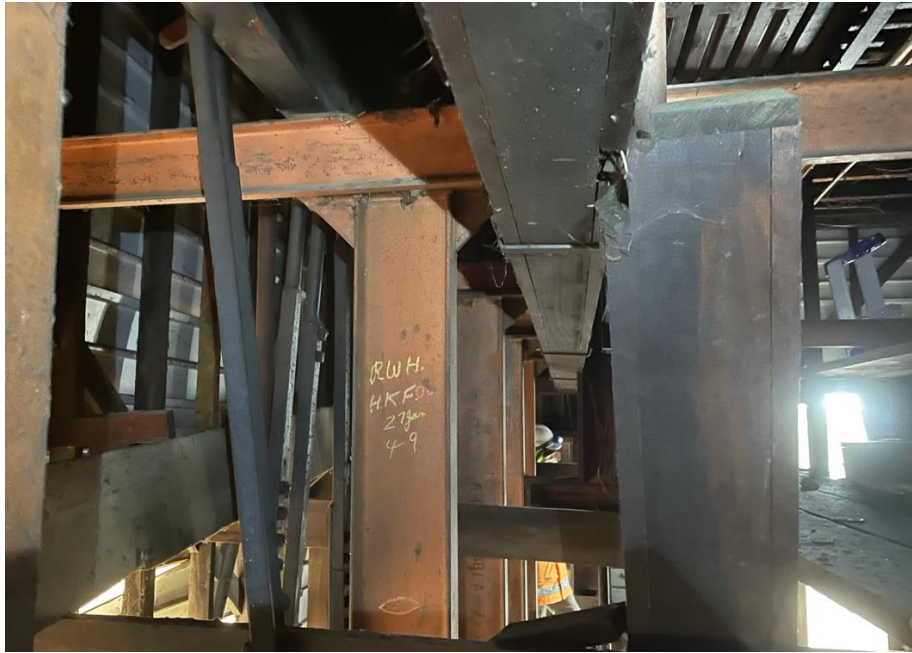
*Figure 3-41: Internal steel lever frame supports*

In regard to the internal steel elements including columns and beams found in the building, it is possible that these materials could be re-purposed. Due to the historical value of these elements, careful consideration of the re-purposing should be undertaken, which could involve offering them to historical railway societies or museums.

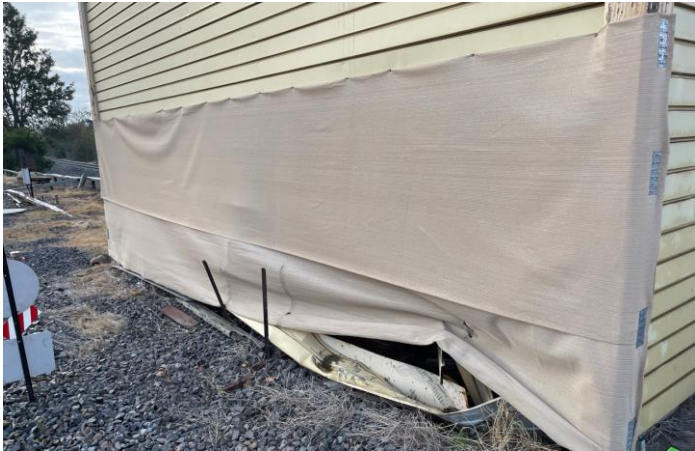
REF	DEFECT DESCRIPTION	PHOTO
<b>FACADE</b>		
1	North elevation of the structure that was impacted by a vehicle collision

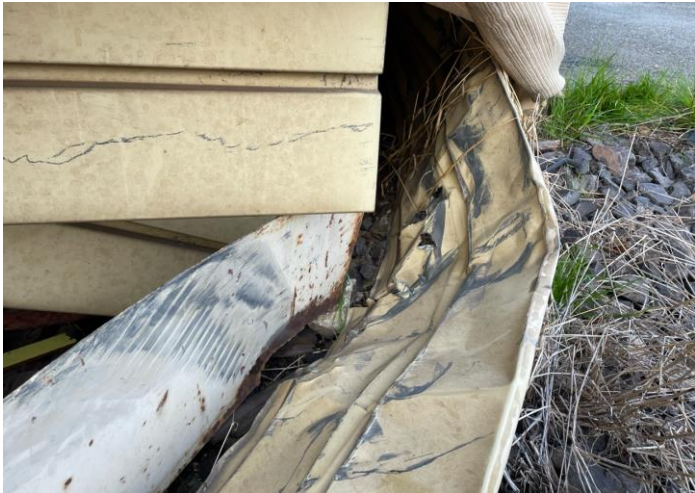
2	Steel wall cladding that has been damaged beyond repair by impact damage

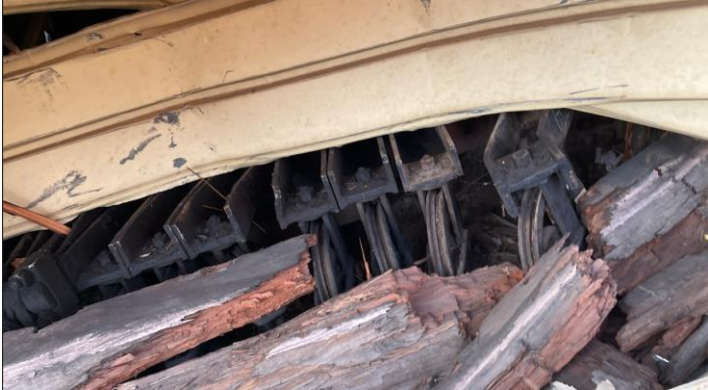
REF	DEFECT DESCRIPTION	PHOTO
3	Steel wall cladding and internal timber wall members damaged beyond repair by impact damage

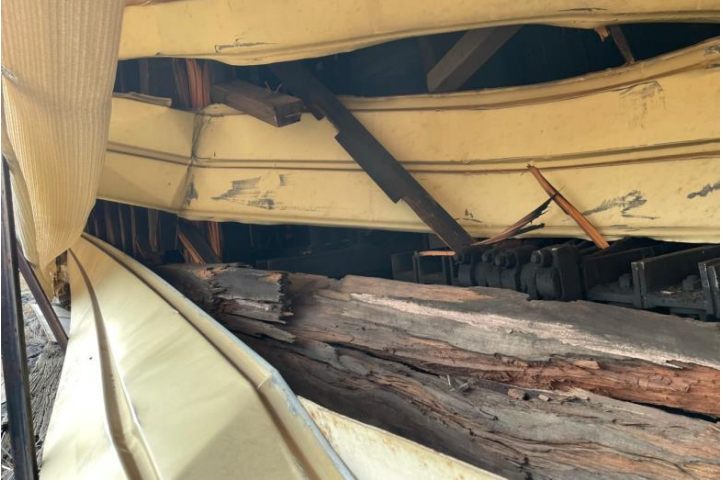
4	Steel wall cladding and internal timber wall members damaged beyond repair by impact damage

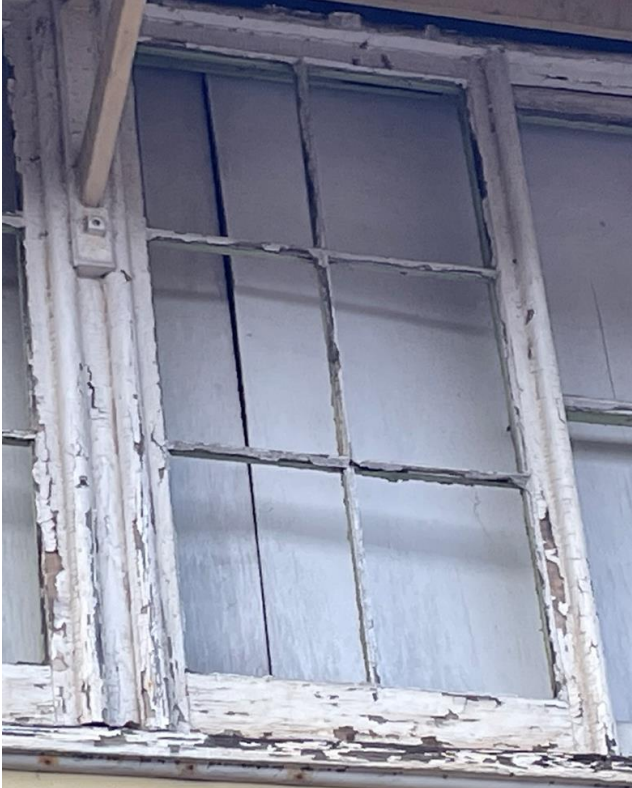
REF	DEFECT DESCRIPTION	PHOTO
5	Splitting and deterioration of protective coating of timber framed windows on north elevation of structure

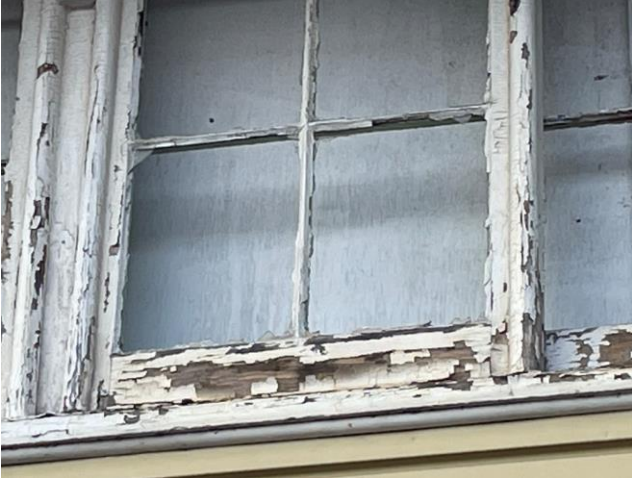
6	Splitting and deterioration of protective coating of timber framed windows on north elevation of structure

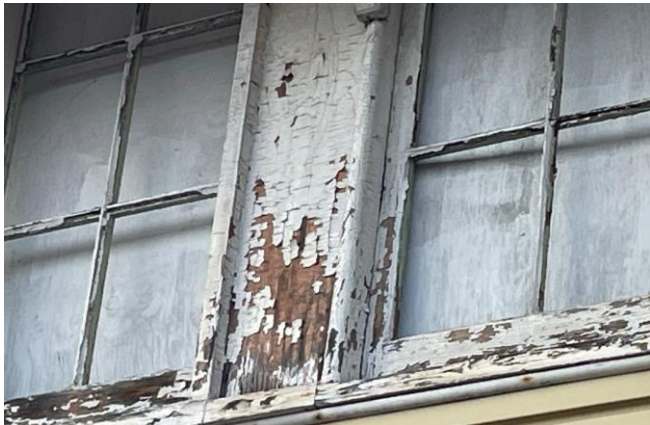
REF	DEFECT DESCRIPTION	PHOTO
7	Splitting and deterioration of protective coating of timber framed windows on north elevation of structure

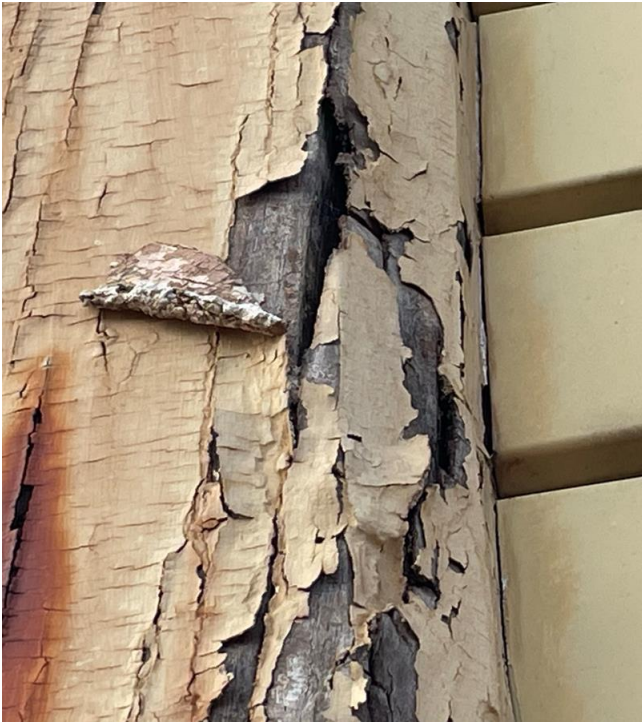
<b>COLUMNS</b>		
8	Severe splitting and deterioration of protective coating system on main timber column on south-west corner of structure

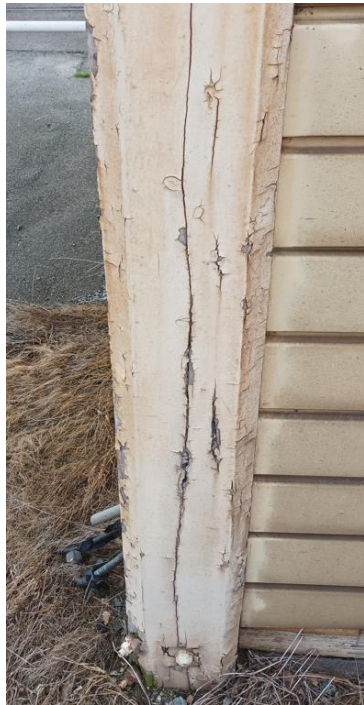
REF	DEFECT DESCRIPTION	PHOTO
9	Splitting of timber column and deterioration of protective coating system on south-west corner of structure

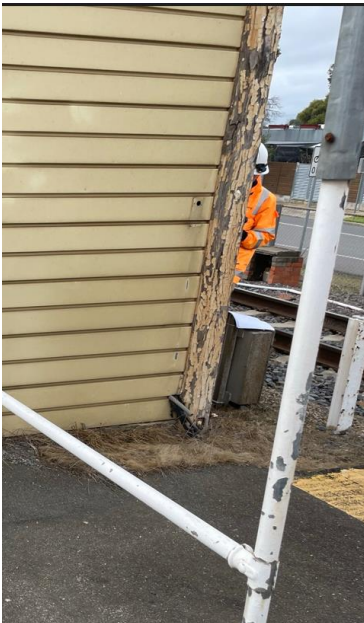
10	Splitting of timber column and deterioration of protective coating system on south-west corner of structure

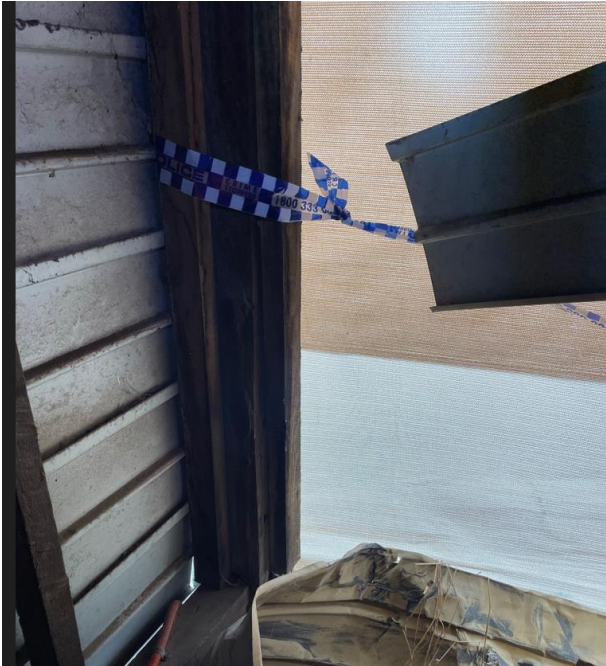
REF	DEFECT DESCRIPTION	PHOTO
11	Main timber column member on the north-west corner of the structure affected by the impact damage

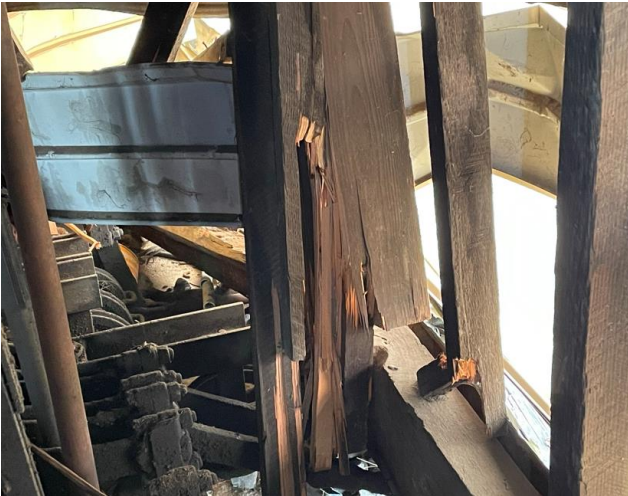
12	Column on northern elevation has been destroyed, presumably by vehicle impact.

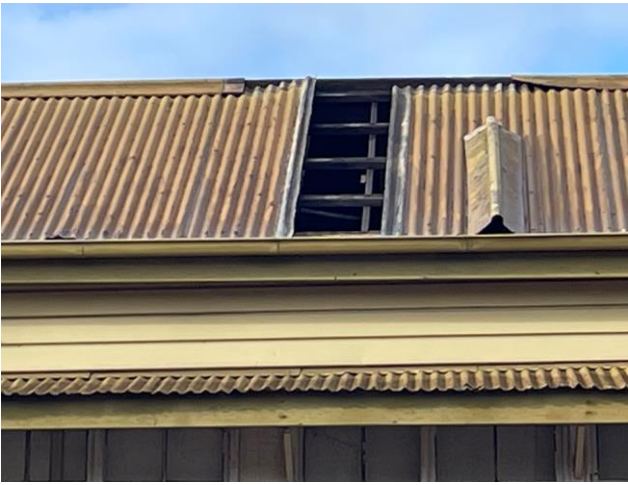
REF	DEFECT DESCRIPTION	PHOTO
13	Section of the corrugated steel roof sheeting missing, and section of the roof ridge displaced and on top of the roof

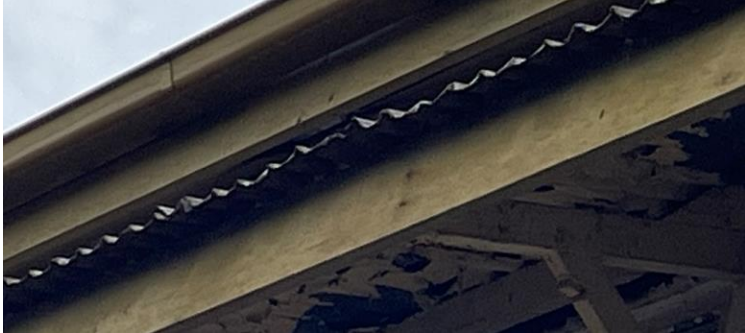
14	Deformed corrugated steel roof sheeting on the lower portion of the roof

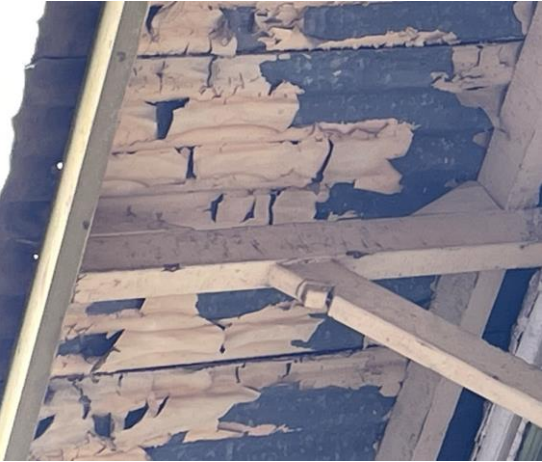
15	Deterioration of the protective coating on the underside of the lower portion of the roof

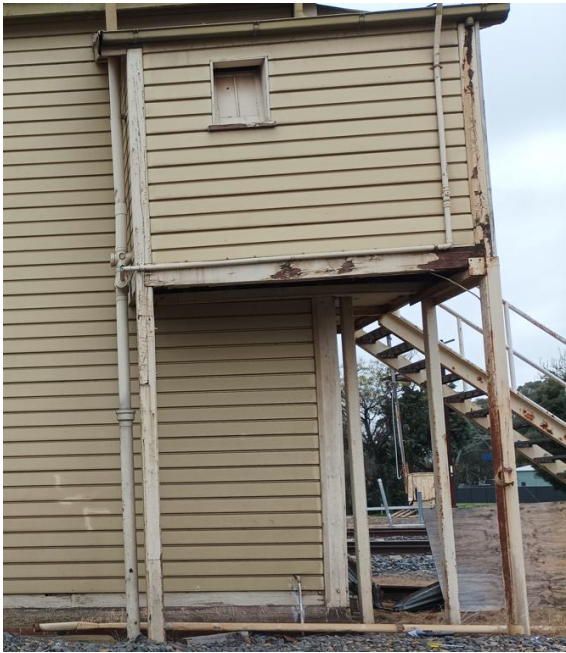
REF	DEFECT DESCRIPTION	PHOTO
16	Non-horizontal beam supporting the first floor toilet

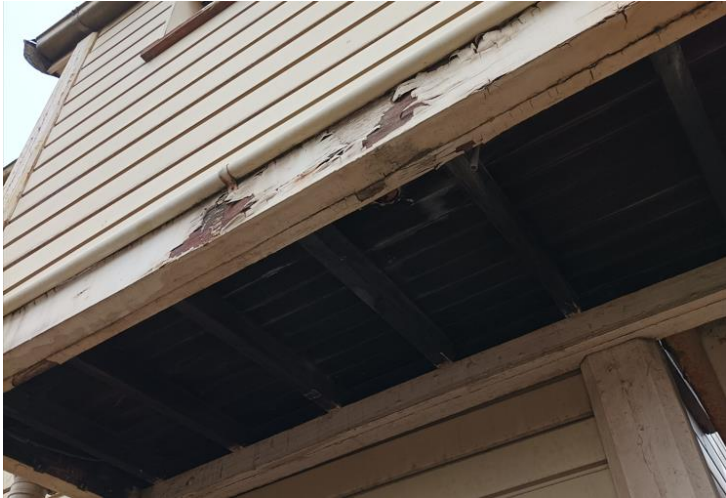
17	Severe splitting in the external timber beams supporting the first floor toilet and deterioration of the protective coating system

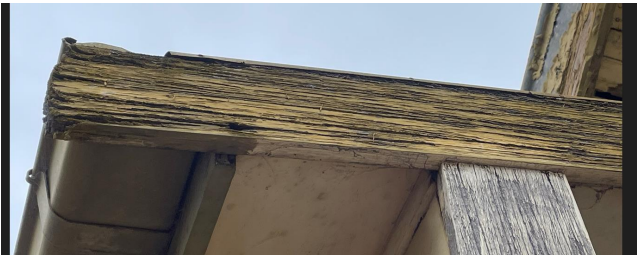
<b>FASCIA, GUTTER AND ROOF SOFFIT</b>		
18	Significant splitting and deterioration of the timber fascia member

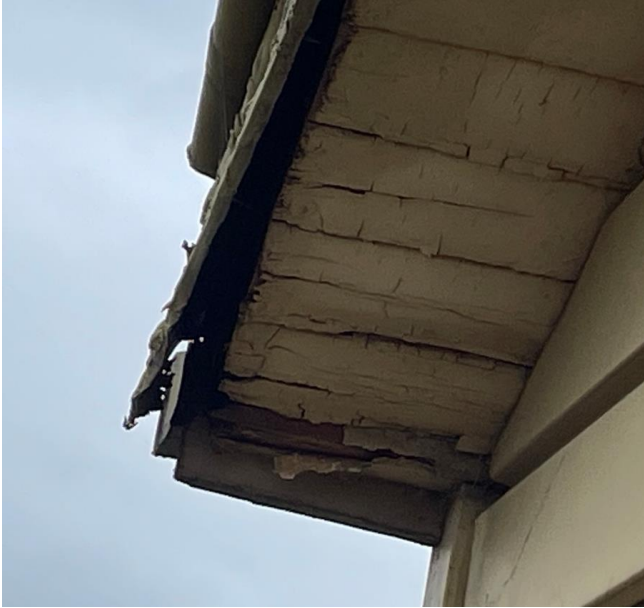
REF	DEFECT DESCRIPTION	PHOTO
19	Disconnected timber fascia member and, splitting and deterioration of the protective coating system of the roof soffit members

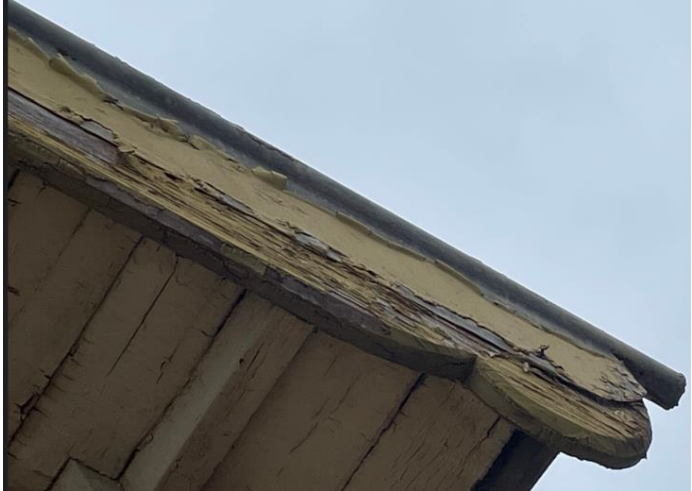
20	Splitting and deterioration of the protective coating system

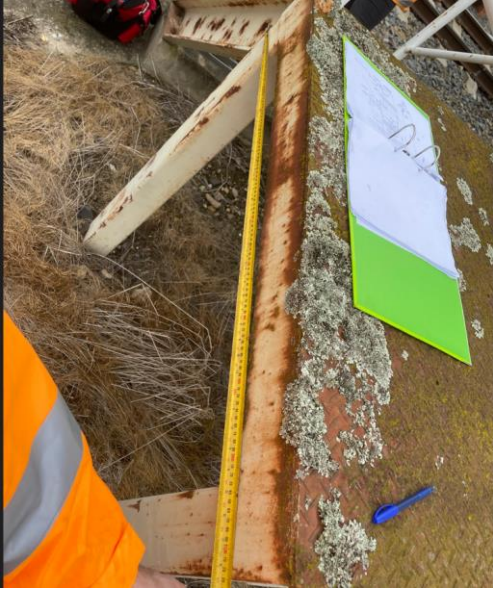
REF	DEFECT DESCRIPTION	PHOTO
21	General surface corrosion that was present of the external staircase

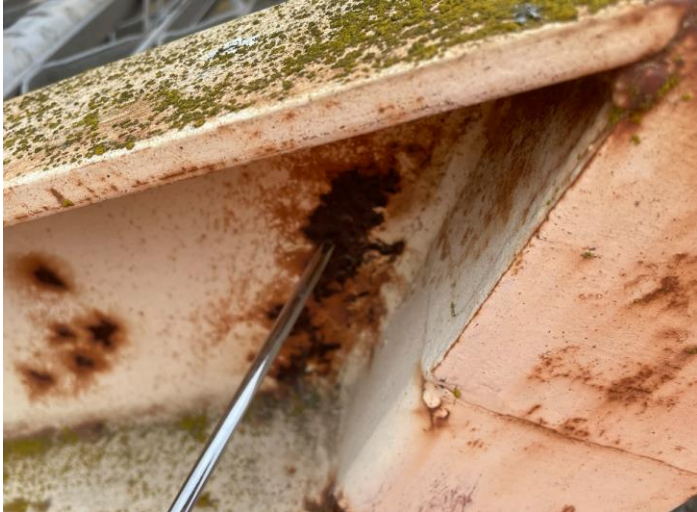
A photograph showing a vertical metal member of an external staircase. The metal is heavily rusted and covered in grey lichen. A yellow measuring tape is placed vertically against the member. To the right, there is a sign with a white top half and a green bottom half, with some handwritten text. A blue pen lies on the ground next to the member. A person wearing an orange high-visibility vest is partially visible on the left.
22	Pitting corrosion located on PFC member of external staircase where stair thread was connected to member

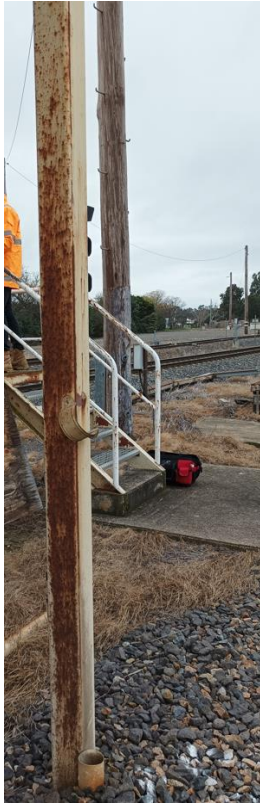
REF	DEFECT DESCRIPTION	PHOTO
23	Surface corrosion of external SHS column section supporting first floor toilet

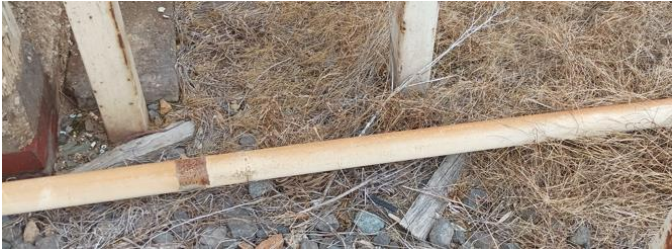
24	Fallen drainage pipe

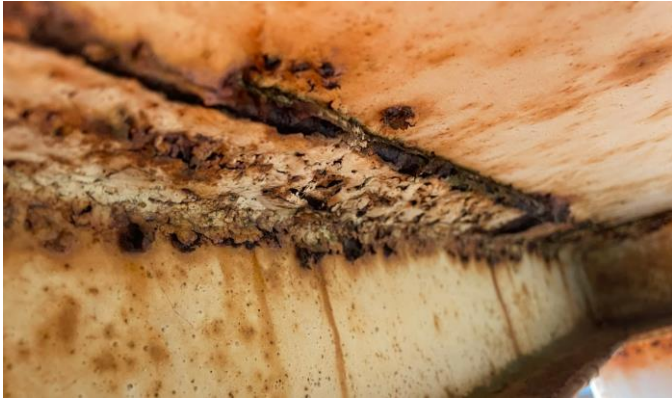
25	Delamination of the connection between the PFC member and the steel platform on the external stairs landing due to corrosion expansion of the steel.

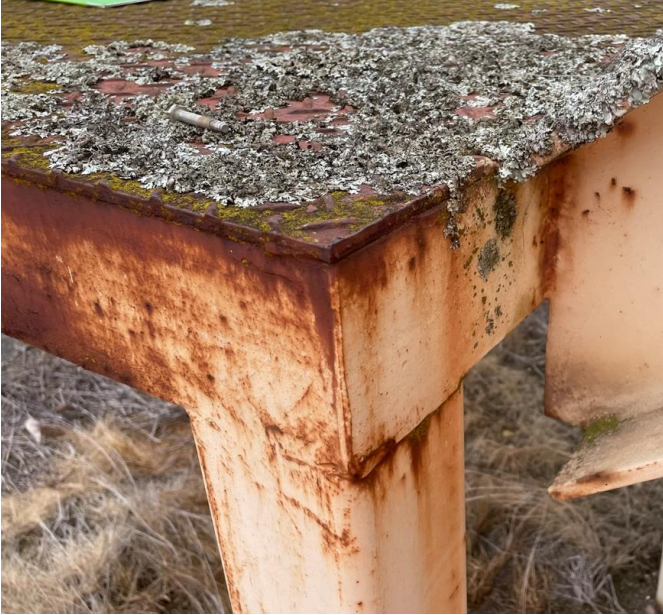
REF	DEFECT DESCRIPTION	PHOTO
26	Surface corrosion and grime present on external staircase landing

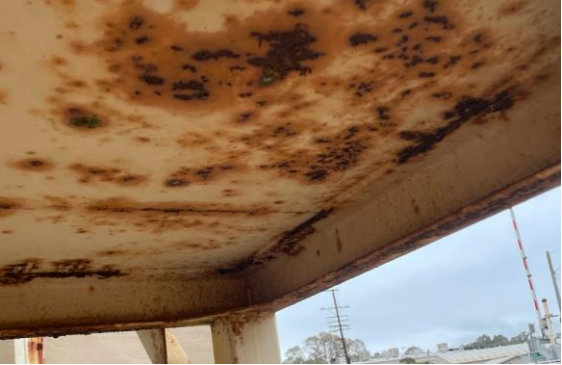
27	Pitting corrosion observed on at the underside of the steel platform landing

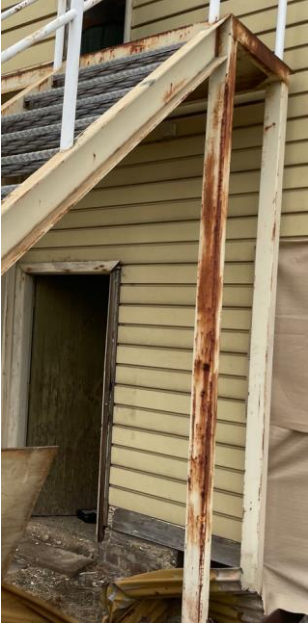
REF	DEFECT DESCRIPTION	PHOTO
28	Surface corrosion of one of the SHS column section supporting the steel staircase

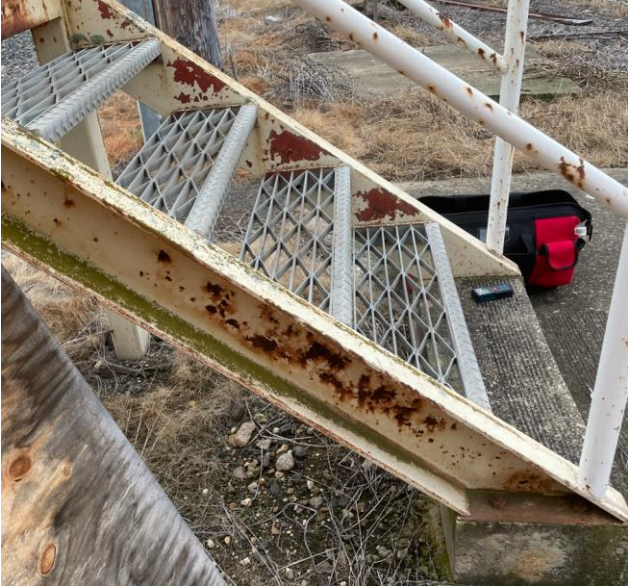
29	Pitting corrosion observed on PFC member
