**ARTC**

**SJ23-0631-RPT-V1**

**Benalla Signal Hut  
Building Inspection Report**

**1<sup>st</sup> September 2023**

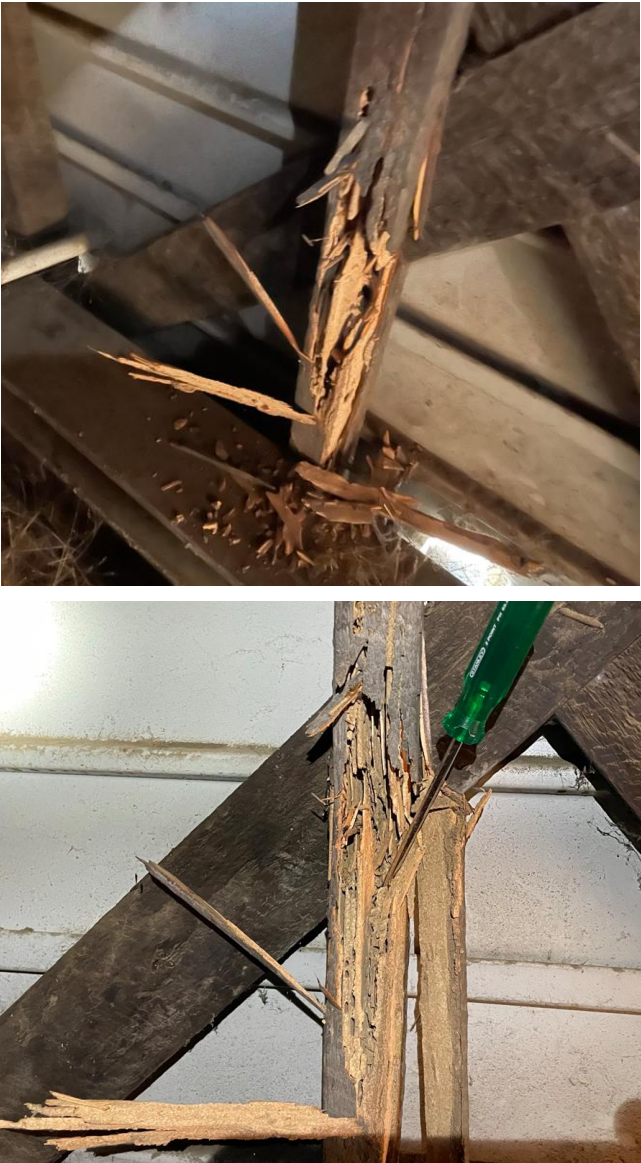
REF	DEFECT DESCRIPTION	PHOTO
<b>INTERNAL WALL ELEMENTS</b>		
30	Structurally failed member, potentially due to the presence of termites

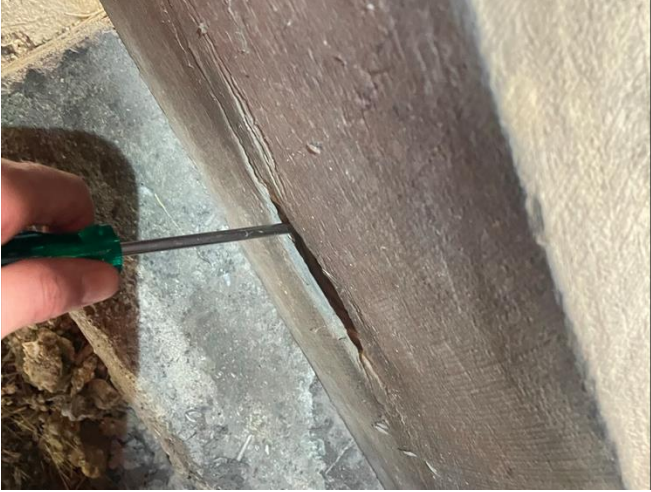
REF	DEFECT DESCRIPTION	PHOTO
31	Severe split in internal column stud member

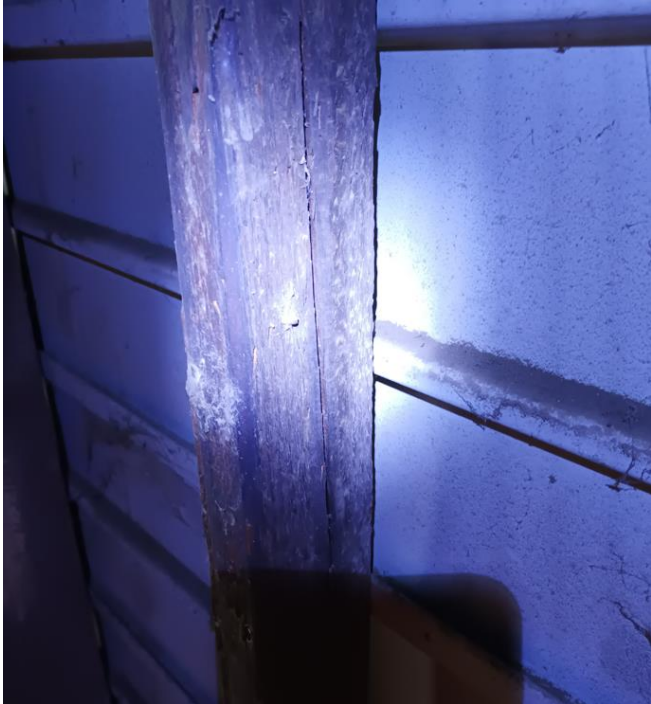
A close-up photograph showing a severe vertical split in a wooden internal column stud member. A hand is holding a green-handled screwdriver, using the tip to probe the depth of the crack. The wood is light-colored and shows significant structural damage.
32	Splitting in internal column stud member

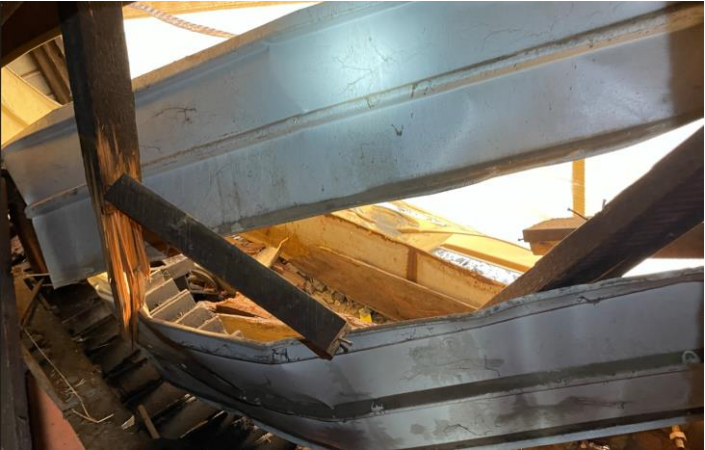
REF	DEFECT DESCRIPTION	PHOTO
33	Severely deformed cladding on the north elevation of the structure due to vehicle impact

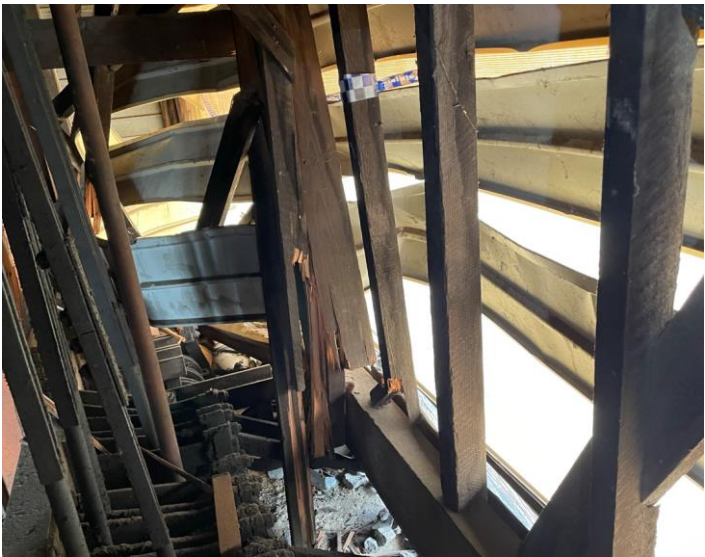
34	Failure of timber studs on the north elevation of the structure due to vehicle impact

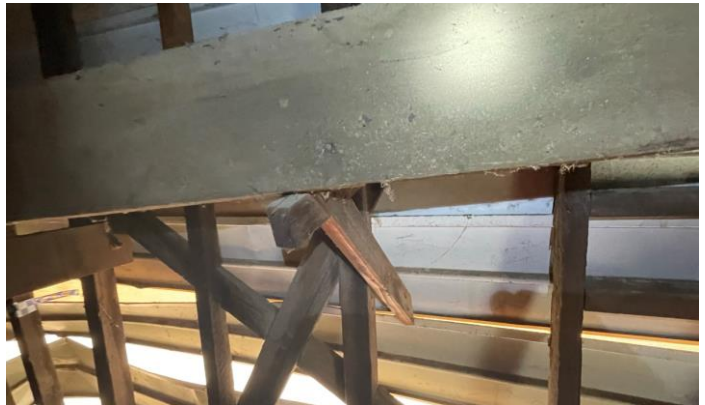
35	Displaced timber beam due to structurally failed timber studs on the north elevation of the structure due to vehicle impact

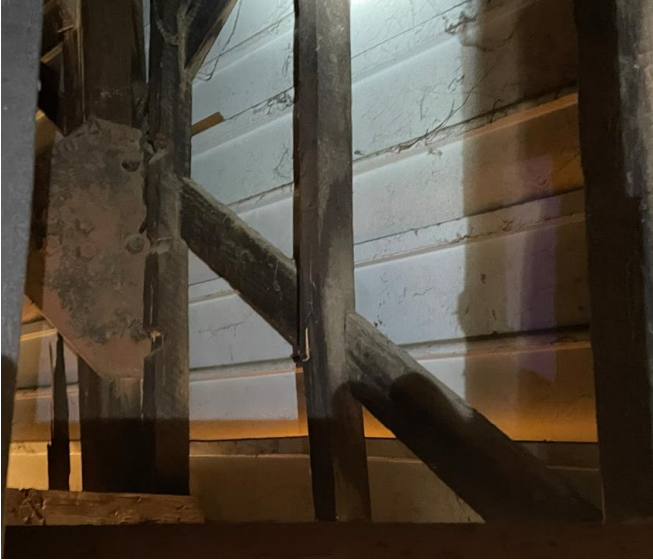
REF	DEFECT DESCRIPTION	PHOTO
36	Failure of timber stud on the north elevation of the structure due to vehicle impact

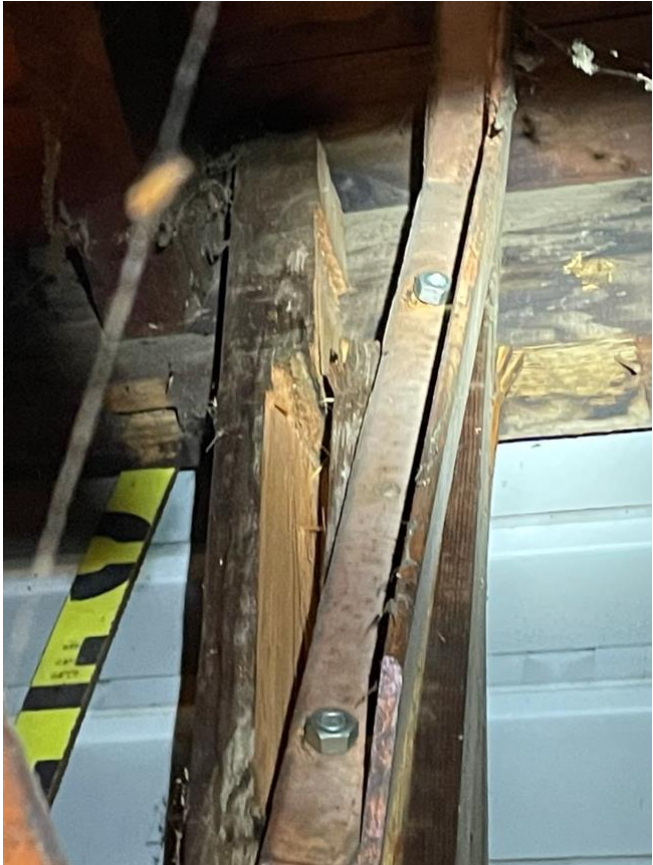
A photograph showing a vertical timber stud that has failed and is leaning away from its original position. The stud is surrounded by other structural members and a wall with horizontal siding. The failure is clearly visible as a gap between the stud and the wall.
37	Failure of timber stud on the north elevation of the structure due to vehicle impact.

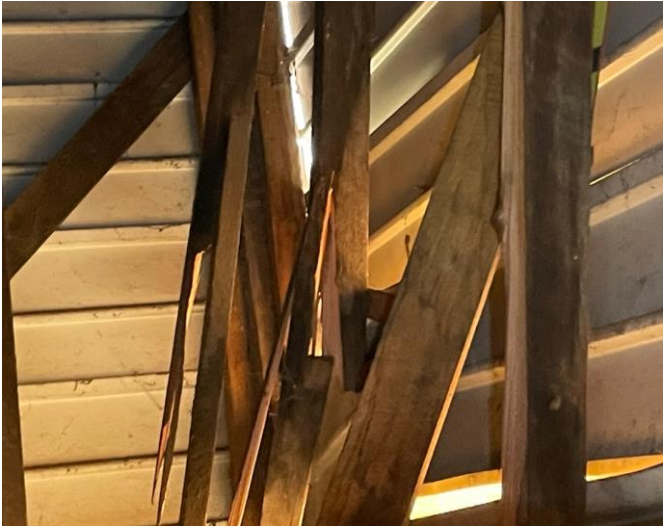
REF	DEFECT DESCRIPTION	PHOTO
38	Failure of timber studs on the north elevation of the structure due to vehicle impact.

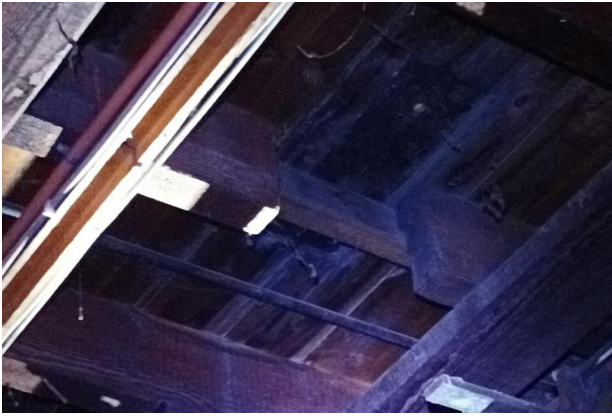
<b>INTERNAL TIMBER FLOORING AND CEILING</b>		
39	Missing portion of one of the timber floor beams at the underside of the first floor.

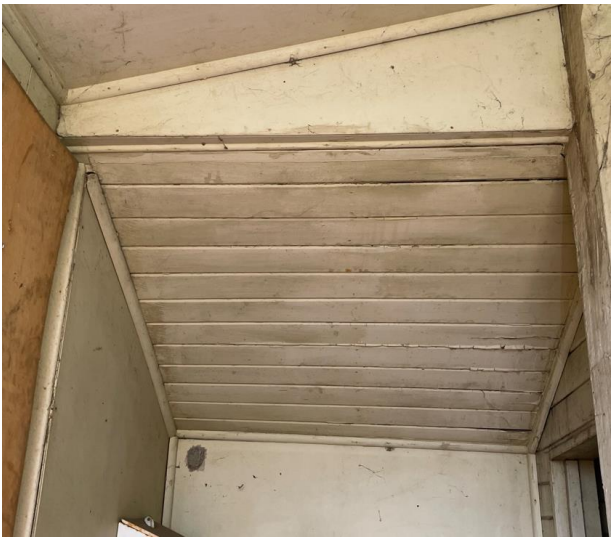
40	Minor splitting and deterioration of the protective coating system for timber ceiling adjacent to toilet.

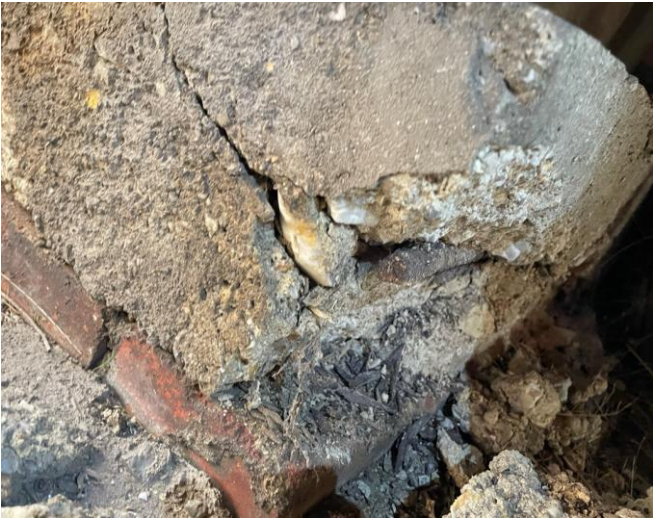
REF	DEFECT DESCRIPTION	PHOTO
<b>MASONRY AND CONCRETE UPSTAND</b>		
41	Concrete missing from concrete and masonry upstand alongside corroded reinforcement on the Down Side elevation of the structure
