Safety

Plant and Fleet Services

BBRPL Issue 050 - 13th December 2007

Falling of 2.5t Overhead Crane Beam

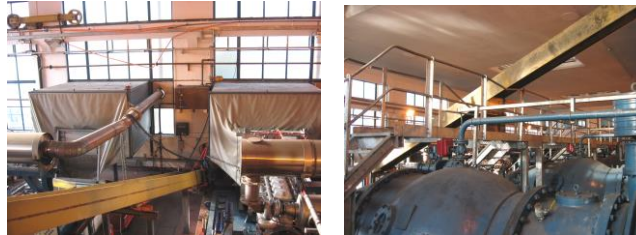
While lifting an overhead crane beam off its carriages with a telehandler as part of a renovation project the load dropped. The original lift plan was found to be not possible and the sub contractor undertook an alternative method with out the Method Statement being re-approved. There was fortunately no personal injury to anyone on site as the area below had been cordoned off as required in the risk assessment.

- All method statements and lift plan changes **MUST** be authorised before work can continue.
- All method statements should be fully reviewed and authorised.
- Competent contractor selection is critical.
- Communication must be improved between all relevant parties.
