Safety Notification

SUBJECT : *Hi-Rail Equipment*

Reference : TCR 4344

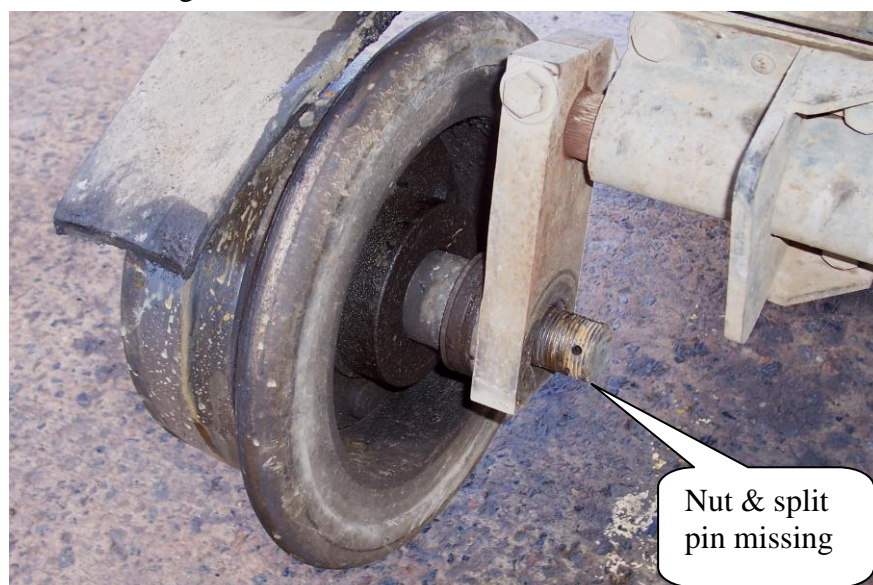
The following example of where a stub axle nut had worked loose over time was not picked up by the operator until the nut was totally missing resulting in a seriously unsafe condition although no incident resulted.

While this condition was initiated by a maintenance fault, the potential for early rectification lies with the vigilance of the vehicle operator in performing routine mechanical safety checks.

Daily pre-start inspections are required on all hi-rail vehicles in accordance with the requirements of *PP139.2F-01 Pre-Start Inspection Report – Rail Guidance Equipment*. These are to be performed to maintain the integrity of the equipment and the subsequent safety of operating personnel.
