ZHA13 -120

Date: 16/10/2013

### Rail Tensor Saddle Snapped

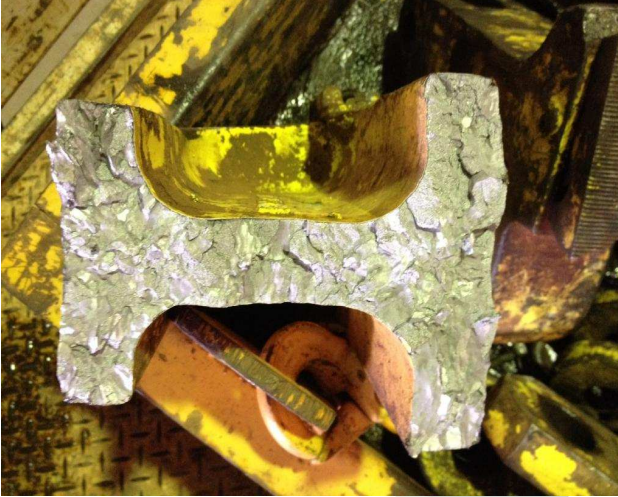
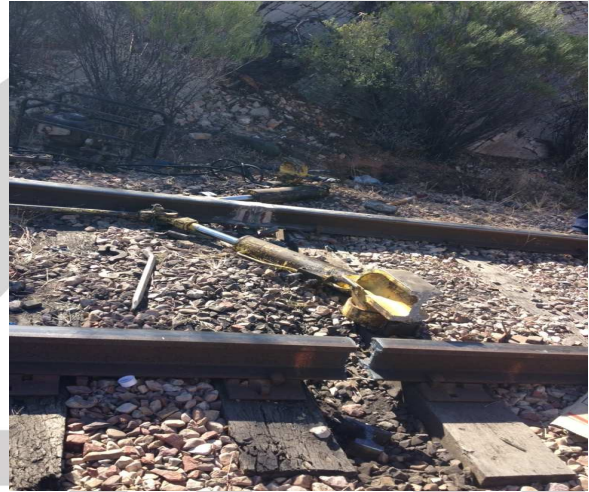
A Downer crew were stress welding rail at Leigh Creek. Once the weld was completed the tensor motor was started to release the tensor gear. The motor ran for about 30 seconds before there was a loud bang and the tensor saddle snapped in half striking both crew members. One crew member was knocked to the ground and the other crew member was struck on the shin.

- There were no signs of stress fatigue in the tensor nor were there any cracks sighted during the pre work inspection.
- The incident is currently under investigation.

All Downer Rail Tensors are to be immediately tagged out of use and Rail Plant Manager advised. The Rail Division Plant Department will arrange for all Downer Tensors to be tested prior to be certified fit for use.

Prior to using a hired Rail Tensor the following inspections must be conducted:

- A Visual Inspection of the Rail jaws and Tie rods for faults.
- Inspect the Tensor hydraulic hoses and cylinders for damage and leaks.
- Check that the Tensor has been tested with a current fit for use certification.
- Prior to engaging the Tensor; the equipment set up must be inspected by a competent person ensuring that the Tensors have a secondary safety device such as safety chains securely fitted.
