Incident No.	INC-63190
Date of Incident	01 st February 2014
Division	Infrastructure/Rail
Business Unit	Eastern Region
Alert No.	006

Worker cut LV cable

SITE:	Epping to Thornleigh Third Track Alliance	
CLASSIFICATION:	ACTUAL DAMAGE: Nil	POTENTIAL DAMAGE: PC1
CONTACT DETAILS:	NAME: Michael Laing	POSITION: Safety Manager
	EMAIL: Michael.Laing@leicon.com.au	CONTACT NUMBER: 0434 076 930

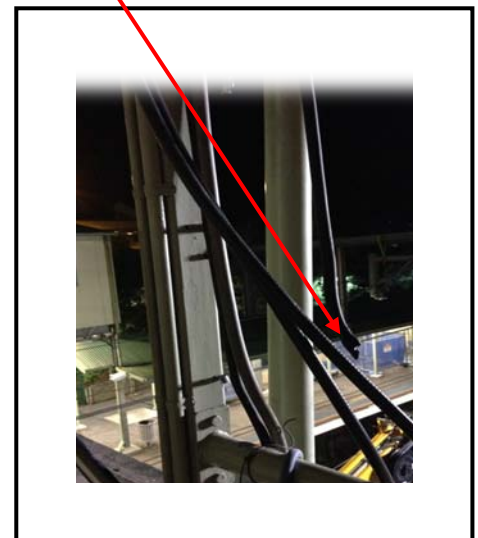
During the possession an issue was raised regarding the telephones in the ticket office not working. Initial investigations could not determine the cause of the issue and a fault was raised to Sydney Trains. It was not known until the Monday that the cause of the fault was due to a live 240v cable being cut as part of the demolition works. The worker who had cut the cable did not receive a shock as a result of the incident.

Photograph showing the end of the cut cable

- There were no formal As-built drawings from Sydney Trains and the Detailed Site Survey (DSS) does not provide a lot of detail at station locations.
- The 240v cable was mislabelled on the drawing as a supply for the help points, whereas it supplied the vending machine. Following site visits and meetings with Sydney Trains, a document of photographs was developed to identify each cable and those that were required to be disconnected.
- No isolation permit was issued prior to demolition work commencing to confirm all isolations and disconnections were complete.

- Ensure a systematic verification of services is agreed and completed prior to any works occurring especially where no As-Built or DSS/DBYD information is available. Where services have been de-energised proof of de-energisation (test for dead), including but not limited to lockout systems, earthing regimes, visible points of disconnection, explosive cable stabber must be undertaken.
- Ensure any service that needs to be tested, verified as dead or removed is only undertaken by the authorised and competent person (eg. electrician).

- Review all demolition work or work around live services to ensure that systematic verification and proof of de-energisation has been conducted for each service and detailed in a valid Isolation Permit.
- Reinforce expectation, understanding and obligation of workers to follow safety instructions and safe systems of works (eg. SHEWMS, Isolation Permits, VOC etc) through project inductions, toolboxes and other methods of consultation. Each person will be held accountable for any deliberate non-compliance and disciplinary measures will be undertaken accordingly.
