No: NR 270

Network Rail Safety Bulletin

Use of petrol driven Stihl Saw: Burns to the leg and hand. Bermondsey Dive Under Project.

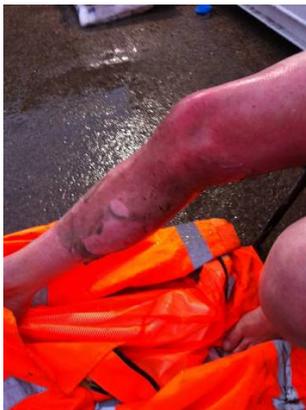
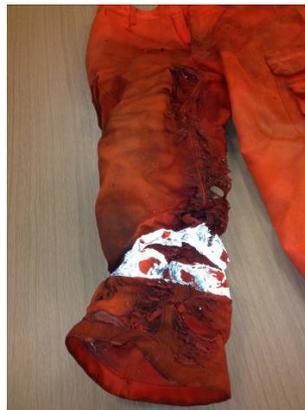
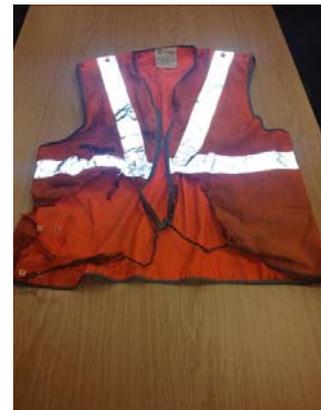
On 21st November 2012, on the Bermondsey Dive Under Project, (part of the Thameslink Programme) an operative was cutting back 32mm thick reinforcement bars that were protruding from recently constructed piles, using a petrol driven Stihl Saw. As he was cutting through a bar, he was unaware that he was being doused with fuel that was escaping from the petrol filler cap. Sparks generated from the cutting, ignited the petrol, which in turn set fire to his right trouser leg and his hi-visibility jacket. The injured person has been diagnosed with serious burns to his right leg and is to remain in hospital pending skin graft surgery.

Although the event is still subject to investigation, the most likely immediate cause(s) of this incident appear to be that petrol was able to escape from its tank, due to a defective filler cap and/or the fuel filler cap had not been secured correctly, following the refuelling of the saw.

- Pre-use checks are required to be undertaken on machinery/tools in order to establish that they are fit for purpose, including making sure that the 'O' ring seal on the fuel cap is in good condition.
- The hand held operation of a Stihl Saw (or any other abrasive wheels) must be in accordance with the manufacturer's manual and supported by a risk assessment. This is particularly relevant in this instance, in relation to cutting with the disc/wheel in the horizontal position.
- Consideration must be given to alternative methods such as hydraulic cutting equipment for the removal of vertically protruding reinforcement bar from piles
