INTERIM SQE ALERT

JHG-01-10

12/01/10

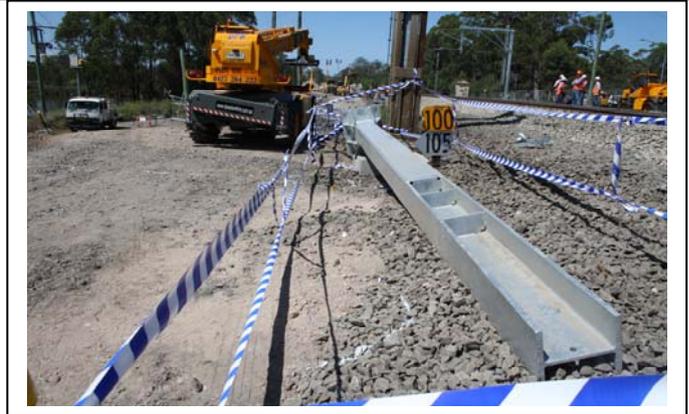
On Sunday 10th January 2010 an 8mm high tensile chain failed whilst lifting a 6.8metre long, 1.2 tonne steel column into position on a NSW Rail project. The column then fell to the ground and toppled over. No persons were injured.

Preliminary investigation of the lift indicated that the chain link failed due to damage sustained as a result of the chain bearing on sharp steel corners. It is not clear if the damage was done during this lift or in previous lifts. Further metallurgical testing will occur.

Pending the results of the metallurgical testing, projects are advised to:

- 1) Immediately inspect all chainsets in use for damage which might cause a chain to have a reduction in its Working Load Limit.
- 2) Ensure that all rigging gear is subject to visual inspection by a competent person prior to use

- 3) Ensure that all rigging gear is subject to regular recorded inspection by a competent person, intervals to be determined based on the duty cycle of the gear, ie, gear in frequent use inspected monthly as a minimum.

- 4) Ensure that best practice techniques are used for the lifting of structural steel, in particular columns, using dedicated lift points where possible, remote or ratchet release shackles as a first preference then synthetic or flexible steel wire rope slings, ahead of reeved chain.

- 5) Ensure that any chain used to lift solid objects has sufficient radius blocks or packers fitted to prevent bending, kinking or gouging of the chain links at the edges of the load.

- 6) Ensure that only "cradle type" chain shorteners are used.
- 7) Ensure that chains are allowed to find their own position in a reeved situation, rather than be knocked down by hammers or dunnage.

- 8) Ensure that lifting gear provided by sub-contractors is fit for purpose before use, including overview of their most recent lifting gear register
