## LP Gas Cylinder Alert

### ATTENTION: Cylinder refillers

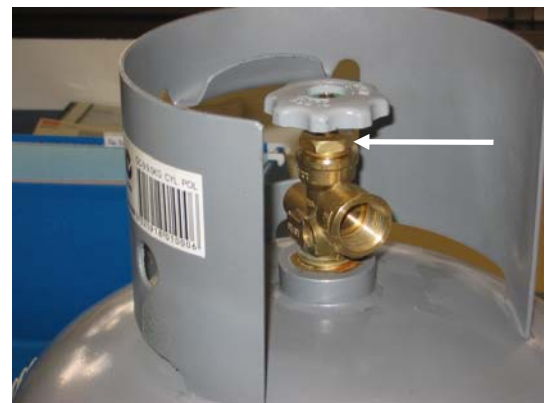
The pictures show the nut which, having a left-hand thread, can be undone during the process of manually turning off the cylinder valve. This may cause the valve assembly to loosen and separate, allowing the immediate release of the cylinder contents under pressure with no real way of stopping the flow once started.

Valve showing loose gland nut

All persons refilling these cylinders are requested to pay particular attention to the tightness of the gland nut. **Remember that this is a left-hand thread and is tightened in an anticlockwise manner.**

All valves on Chinese manufactured cylinders should be checked as a matter of course and any loose nuts found reported to this office. Tightening should ensure that the valve gland nut is well-secured in place. **IF IN ANY DOUBT, DO NOT FILL THE CYLINDER.**

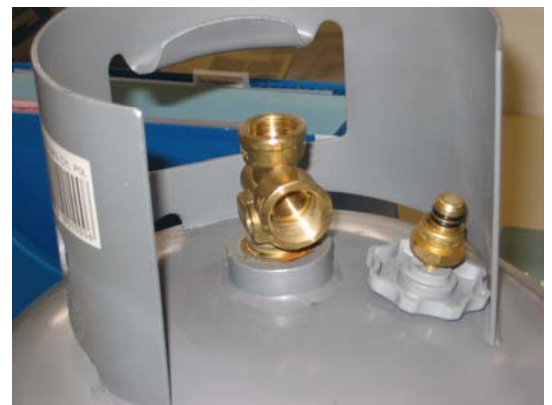
Valve can fall apart during closing action
