Australian Rail Track Corporation Ltd

# SAFETY ALERT

ARTC NSW No. 34

## USING THE RIGHT TOOL/EQUIPMENT

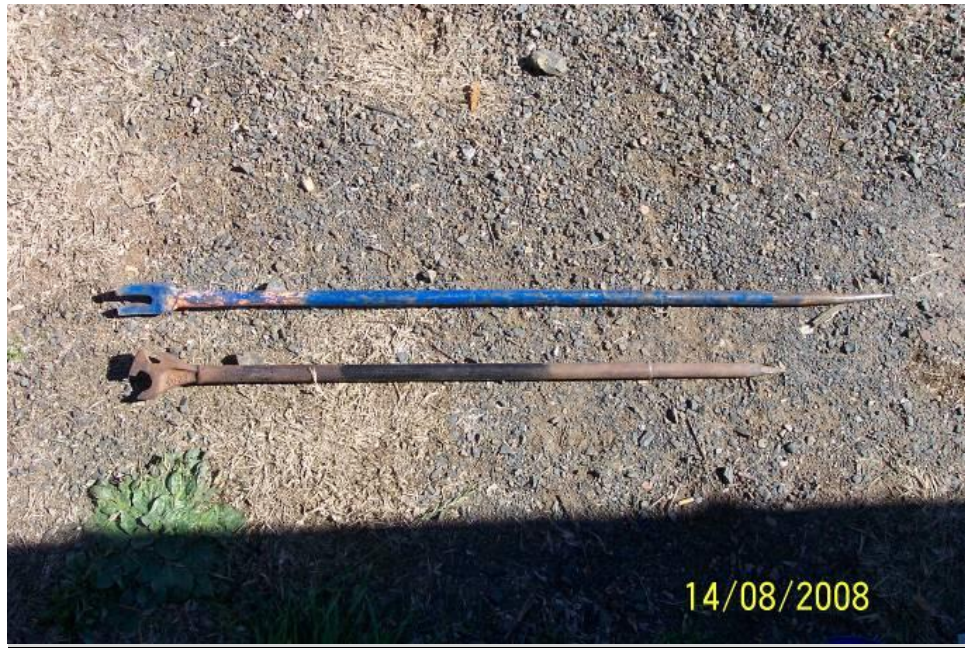
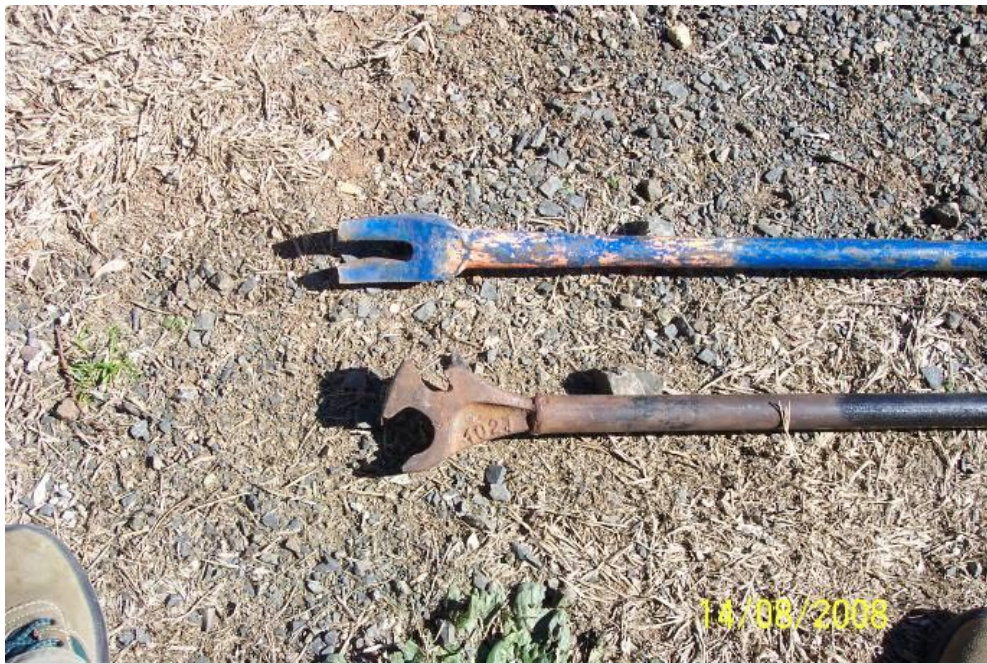
**Claw Bar – the blue bar above**

**Rail Turning bar at bottom of picture**

Employees are to be instructed that the right tool/equipment is to be used for the task at hand

Claws Bars not to be used for “rolling” lengths of rail line
