Australian Rail Track Corporation Ltd

SAFETY ALERT

ARTC NSW No. 35

TOOL/EQUIPMENT INSPECTION

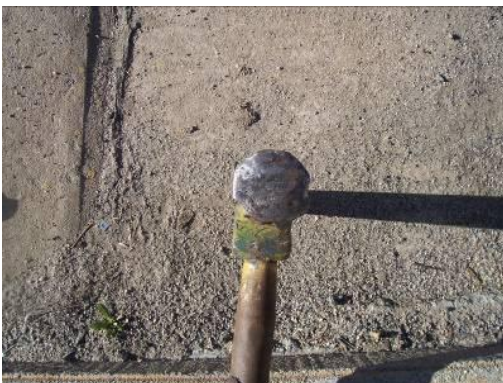
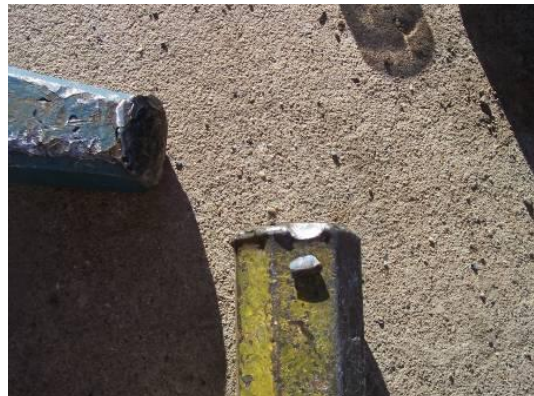
A “spiking hammer” was being used

A piece of metal split from the hammer head and became a missile – striking the employee in the face. The employee required stitches

The hammer head was manufactured from “hardened steel” and was not expected to “mushroom or splinter”

ALL HAND TOOLS OR EQUIPMENT THAT INVOLVES METAL ON METAL USE, (eg. Hammers, bars) ARE TO BE INSPECTED IMMEDIATELY. ANY DEFECTIVE OR FAULTY EQUIPMENT NEEDS TO BE “TAGGED OUT” AND REMOVED FROM SERVICE

All tools/equipment needs to be inspected, on a regular basis, prior to use. With some tools, this may mean inspecting every time before they are used. This especially applies to tools where there is metal striking metal during their use/operation. Tools need to be inspected for “mushrooming”, cracks, splits and un-even wear.
