Light Vehicle Rim Cracking

Mine Type: All Surface Mines

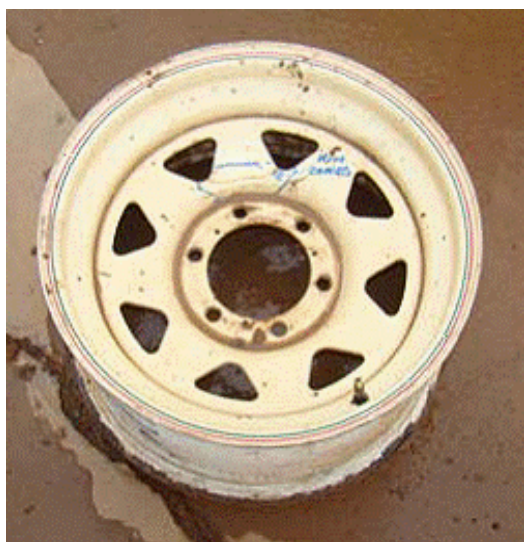
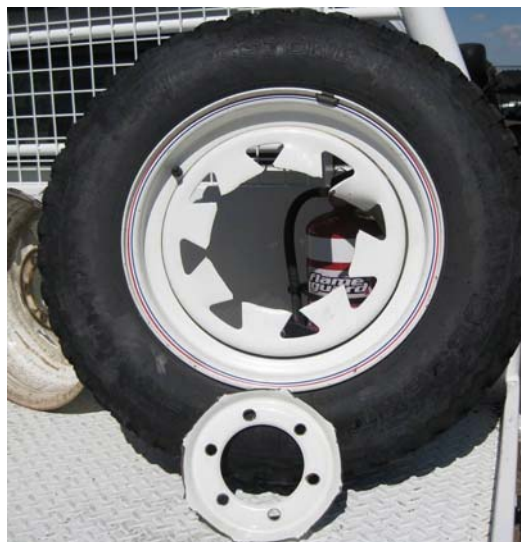
Incident: While towing a trailer with a four wheel drive vehicle, the driver noticed a change to the steering. A check revealed one of the wheel rims had split. An investigation at the mine then discovered many light vehicle rims were also cracked, but to a lesser extent.

Equipment: Drop centre 16x7 SUNRAYSIA style wheel rims for use on four wheel drive vehicles.

Cause: Fatigue cracking, initiating on the internally facing side of the rim, around the base of the spokes.

- Identify vehicles with SUNRAYSIA style rims; remove and inspect the internal rim face for cracking.
- Check with Original Equipment Manufacturers on the style of rim suitable for the required duty.
- Replace all cracked or suspect rims with only that style of rim identified above.
