SA 12-201 - Safe operation of Franna cranes

PLANT ROLL-OVER RISKS DURING ROAD CONSTRUCTION

COMPACTION ROLLER RISKS NEAR EDGES OF EMBANKMENTS

DOG TRAILER ROLL-OVERS

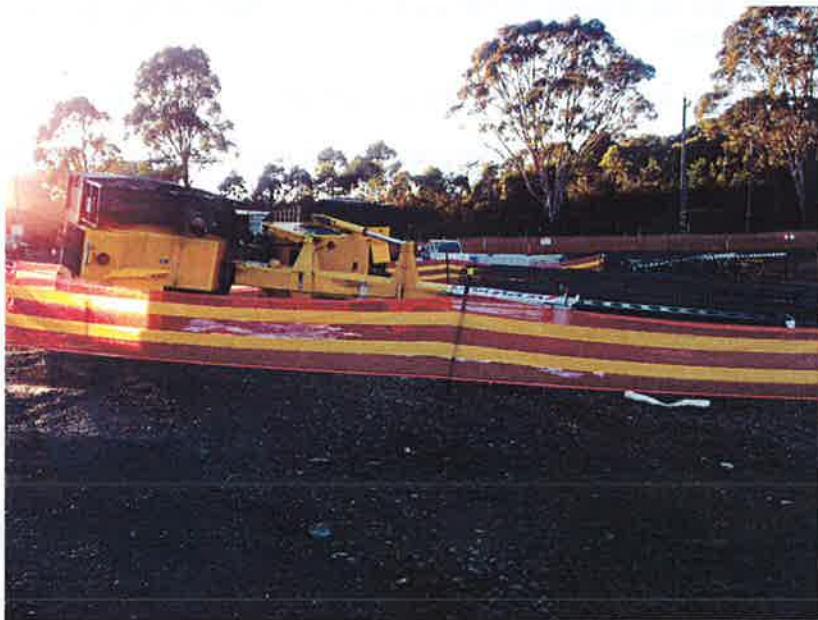
There have been two recent incidents, one of which was on a Transport Projects site when a Franna crane tipped over whilst conducting "pick and carry" operations. Whilst investigations are ongoing into the causes of both incidents, this Safety Alert is to serve as a reminder for when operating this type of crane.

The rated lifting capacity of Franna cranes is based on working on a firm level surface (1% slope, 0.6 deg as per AS1418.5) with tyres inflated to correct pressures. Any deviation from this standard will derate the lifting capacity.

- With pick and carry operations, the load shall be carried with the minimum boom length and as close to the ground as possible at speeds **NOT** exceeding 1.4 km/h (0.4 m/s) – half the speed of walking pace.

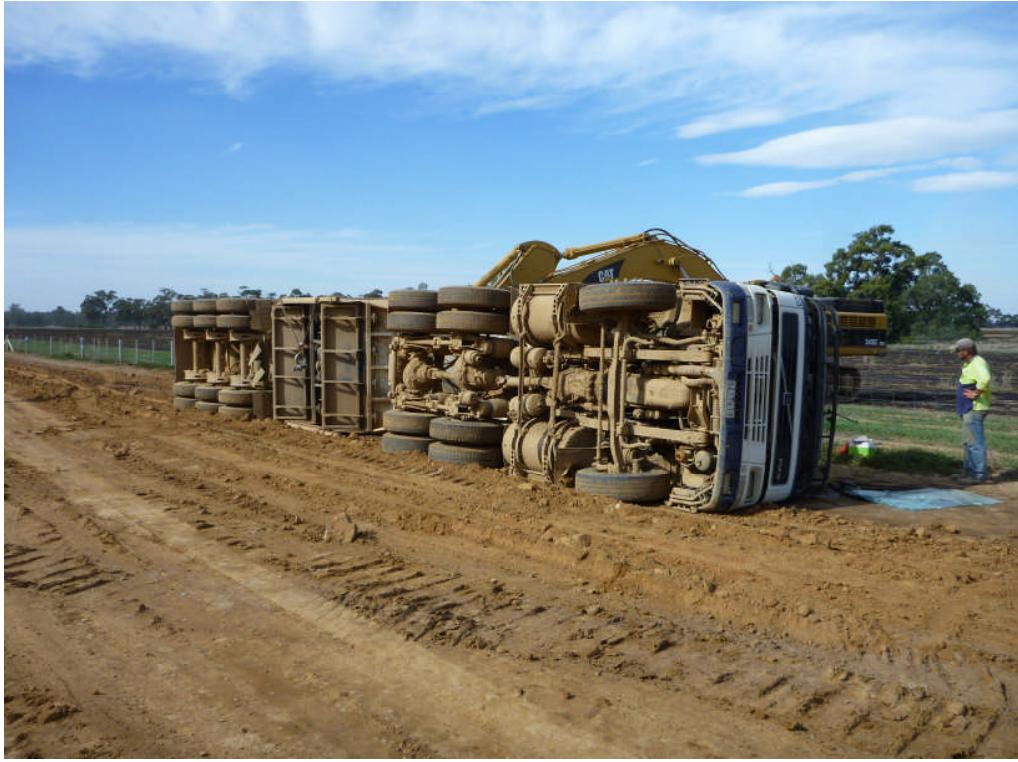
The contractor investigated the incident and considers the essential contributing factor to have been the use of unsuitable 'sticky / wet' material being used in the Belly Dumper. A large amount of material was stuck on the inside left of the trailer hopper which caused the dumper to become unstable during travel.

As the dumper moved forward some of this loose material was fed under the right hand trailer wheels causing the vehicle to lean further to the left and eventually the trailer to tip over onto its side taking the prime mover with it.

Belly Dumper after the Incident

The use of Belly Dumpers with this material has been discontinued on the project concerned.

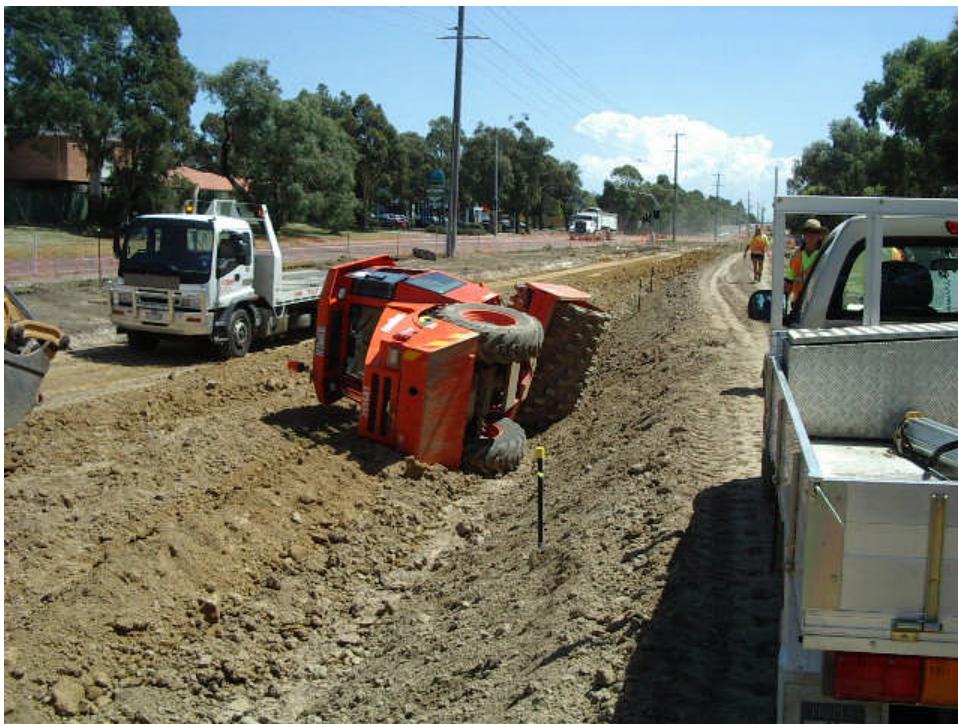
Rollers continue to roll-over the edges of embankments during earthworks compaction on projects. Fortunately the embankments are often of a small height and the roller tips onto its side with minor injury (usually) to the plant operator. However, if a roll-over occurs on a high embankment it is likely the machine could roll from top to bottom with a real potential for serious injury to the operator.

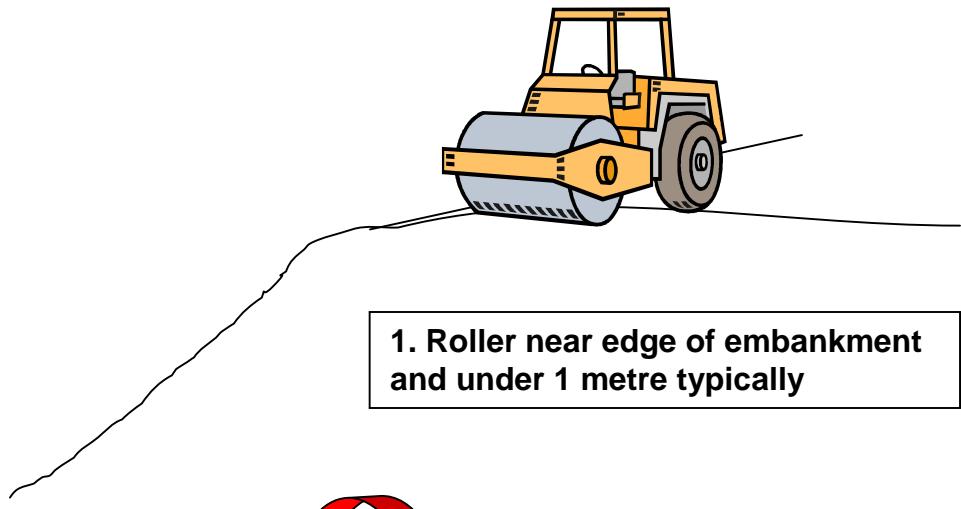
1. Roller near edge of embankment and under 1 metre typically

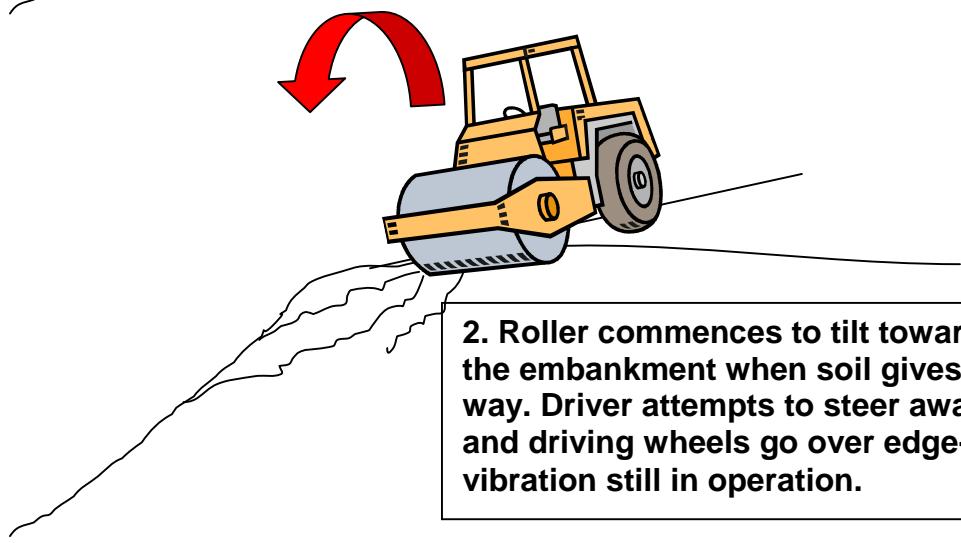
2. Roller commences to tilt towards the embankment when soil gives way. Driver attempts to steer away and driving wheels go over edge-vibration still in operation.

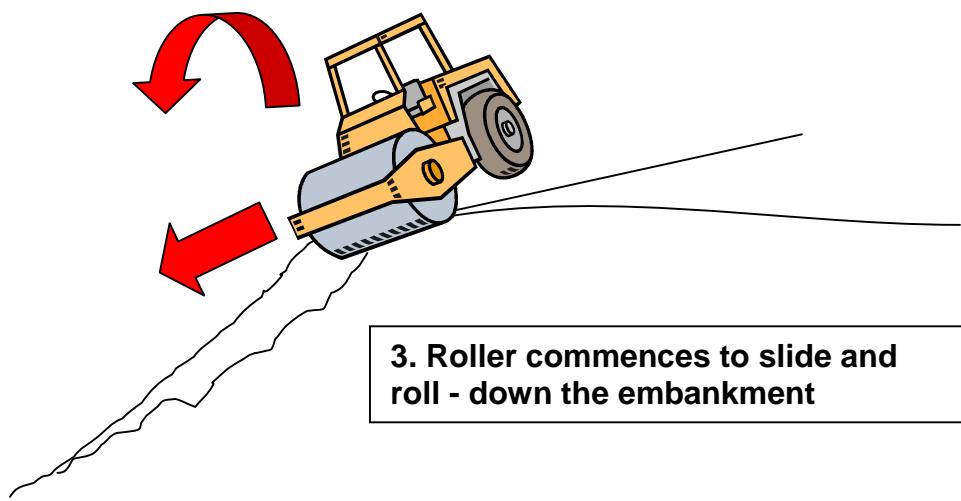
3. Roller commences to slide and roll - down the embankment

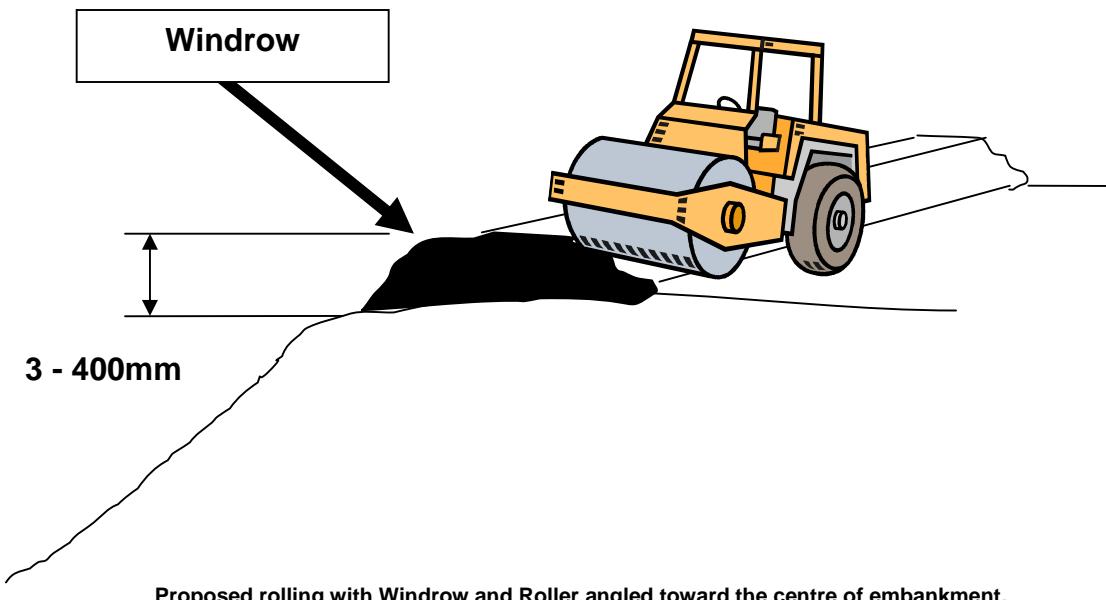
Proposed rolling with Windrow and Roller angled toward the centre of embankment.

Where it is necessary to roll closer than 1 metre to the edge the rolling should be conducted at an angle of about 45 degrees. This ensures the bulk of the roller is on firm compacted soil and the drive wheels are able to retain traction.

Operators experienced in this type of work also recommend that windrows be constructed near the edges and that the rollers are operated so that they retain a slight lean towards the centre of the earthworks rather than roll with the machine in the vertical when near the edges. This approach will result in the roller leaning away from the edge of the embankment further reducing the likelihood the machine will roll over the edge and down the embankment.

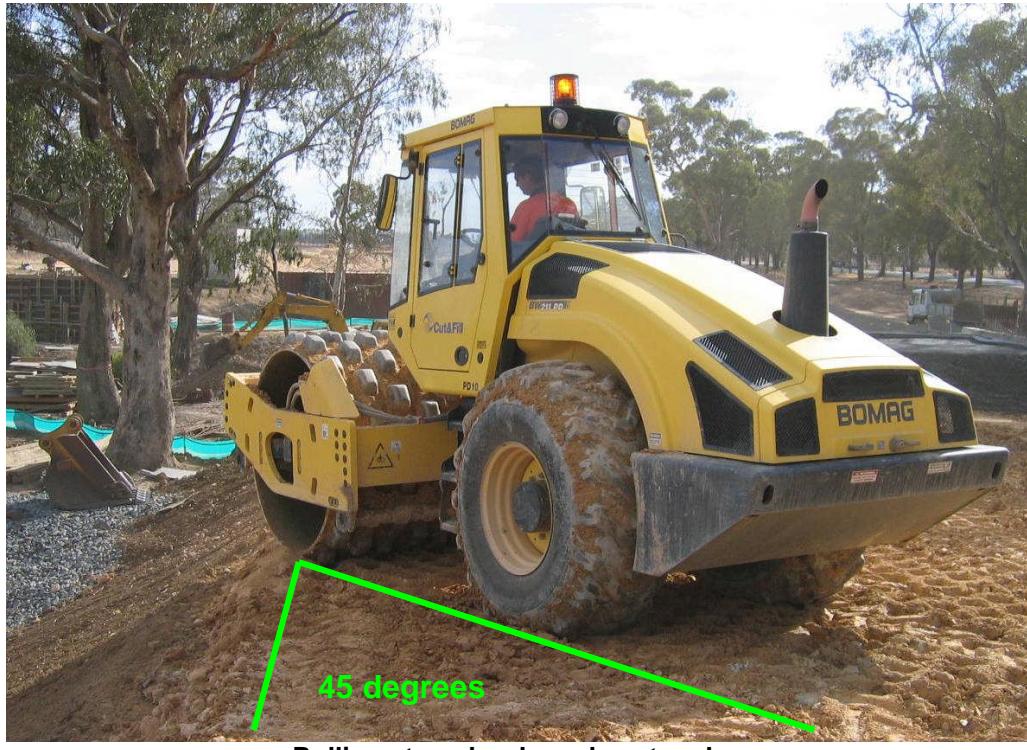
Rolling at angle when close to edge

- (f) In confined areas such as fills at bridge abutments, keep outer edges of fill higher and roll at angle to the edge of fills (Refer pictures on following pages). Rolling slowly to the edges of fill, stop machine and vibration if there is any sign of instability and reverse away.

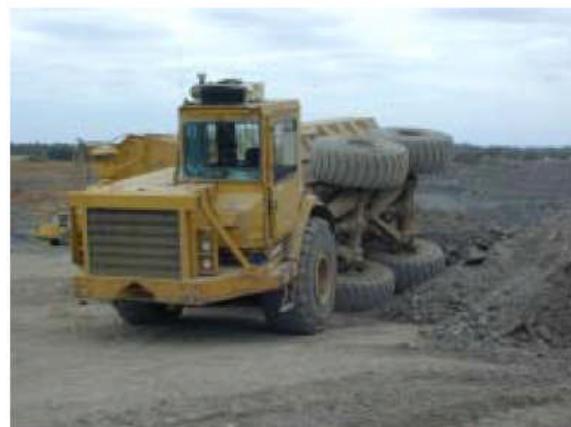
In most cases the driver reversed the truck to either dump a load or allow other vehicles to pass. The rear wheels on one side climbed up the windrow or the previously dumped load. In some circumstances a change in height of 60 to 70cm in one rear wheel set was sufficient for the tub to over balance and roll over (see photograph).

1. Carry out a site specific risk assessment to determine suitability of this style of vehicle for your mine site. The risk assessment should include but not be limited to the following:

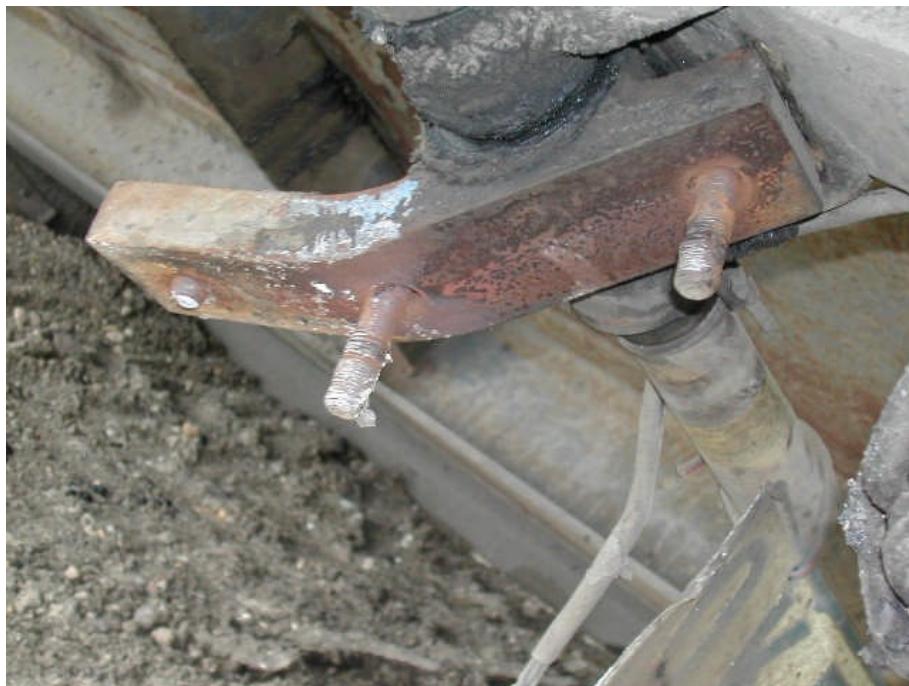
- Loose bolts and cracking in welds and support rails were evident in the tipper body chassis connection that failed under tipping load conditions.
- An estimated one tonne of cold asphalt had stuck to the floor of the truck body subsequently contributing to the tip body slewing to the right side.
- The floor of the truck body had not been cleaned prior to loading preventing the hot asphalt discharging and placing extra loading at the top end
- There had been no slip agent applied to the tipper body prior to loading.
- The Plant Daily Check Sheet indicated the truck as roadworthy when the tyres were later deemed unroadworthy

Tipper Body Frame Securing Bolts without Nuts

- Revising cartage contract specifications to require frame integrity inspection and roadworthy expectations, in addition to existing requirements for Plant to be maintained in accordance with the manufacturer specifications and Plant Regulation requirements.
- Appointing a qualified person to inspect cartage trucks on a regular basis
- Asphalt Depot Procedures to include requirement not to load trucks with excessive asphalt build-up in trays
- Ensure all truck bodies are cleaned out on a regular basis to prevent the build-up of material. Slip agent sprays fitted at loading points to spray truck bodies with 'Asfaltrent'.
- Implement a training session for drivers of asphalt cartage trucks.
- Ensure all personnel on site are made aware of the risks near operating plant and to keep clear
