ZHA-12-52**Date: 01/08/2012**

Serious Foot Injury

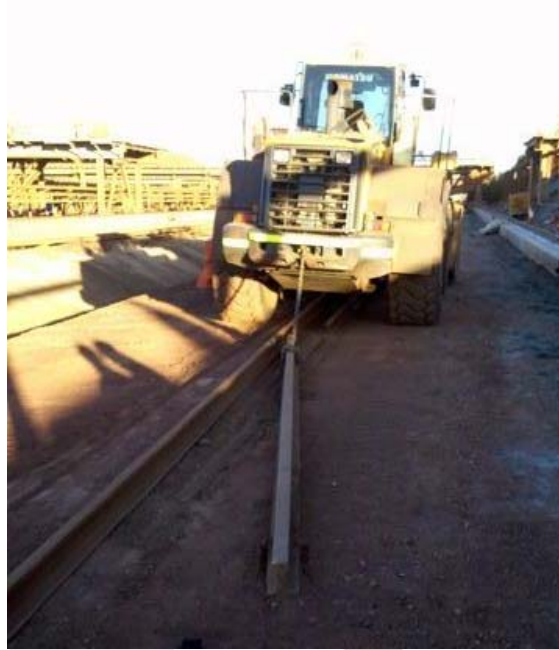
- > A Downer Group working on a Rio Tinto Site in Western Australia were dragging a 6.5 metre length of rail using a loader and a chain. The work group consisted of a Loader Operator from Downer West Civil Business and two Spotters from Downer Specialist Services – Rail Division.
- > As the rail was being dragged into position for future work, it struck a stationary piece of rail causing the rail to kick upwards striking an employee's left foot.
- > The Employee suffered multiple fractures, de-gloving of the foot, damaging arteries and causing other serious complications.
- > The Employee will require a series of surgeries and pro-longed intensive rehabilitation.

- > The incident is currently under investigation by Rio Tinto and Downer Infrastructure, DASS Rail Division/Downer West Civil.
- > A designated exclusion zone was not exclusively determined.
- > Initial investigations indicate that there was a lack of supervision of a young, inexperienced employee.

Project Managers / Supervisors must complete a minimum of 4 zero harm observation forms in the month of August that focus on the following:-

- Pre start briefs and identification of site hazards;
- Plant Pedestrian Interface;
- Site Traffic Management Plans;
- Supervision of Work Groups; and
- Training and Competencies.

Project Managers are to ensure that there is adequate supervision on site and that all employees and contractors have the skills, attributes and experience to perform the tasks that they have been assigned safely.
