Australian Rail Track Corporation Ltd

SAFETY ALERT

ARTC NSW No. 66

HAMMER INSPECTION

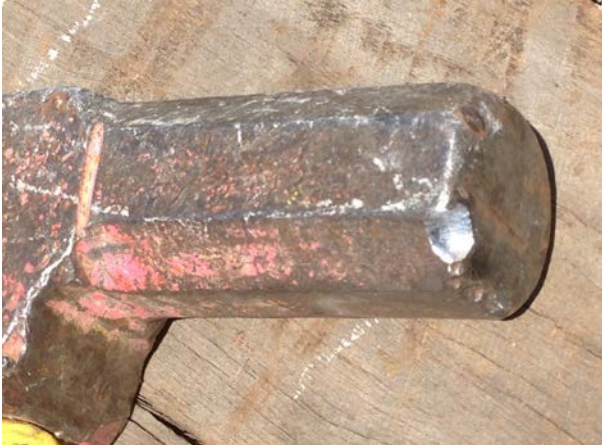
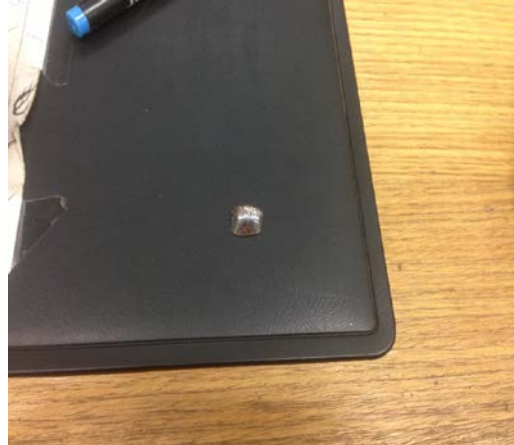
Unknown to the worker at the time, a metal fragment broke off the hammer and struck the worker on the leg. It was not until the worker felt “dampness on his trousers” that he noted blood coming from a laceration to his leg.

The worker was wearing long trousers

ALL HAMMERS ARE TO BE INSPECTED IMMEDIATELY. ANY DEFECTIVE OR FAULTY EQUIPMENT NEEDS TO BE “TAGGED OUT” AND REMOVED FROM SERVICE

All tools/equipment need to be inspected, on a regular basis, prior to use. With some tools, this may mean inspecting every time before they are used. This especially applies to tools where there is metal striking metal during their use/operation. Tools need to be inspected for “mushrooming”, cracks, splits and un-even wear.
