# Safety Alert

## NOTICE TO RAIL TRANSPORT OPERATORS

RSA-2013-02 Date Issued 18 November 2013

Coupling Systems and Brake Systems Fitted to Infrastructure Trolleys and Trailers

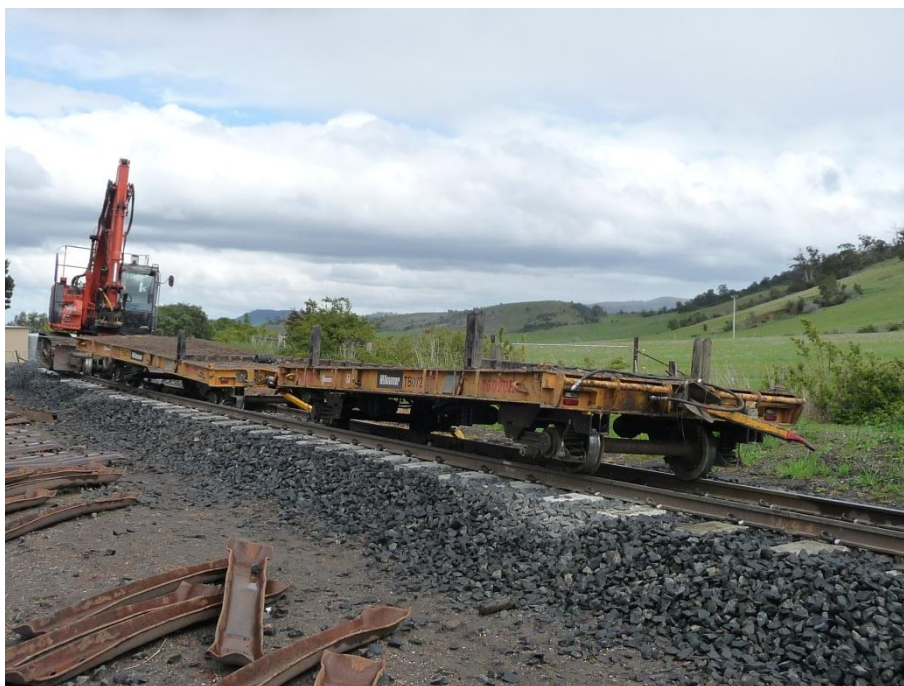
On 9 November 2013 as a result of the derailment of a rail mounted excavator, the two trailers which it was towing became detached and ran away, subsequently colliding with a second rail mounted excavator which was located 6 kilometers away from the original derailment site.

Figure 1: Point of collision

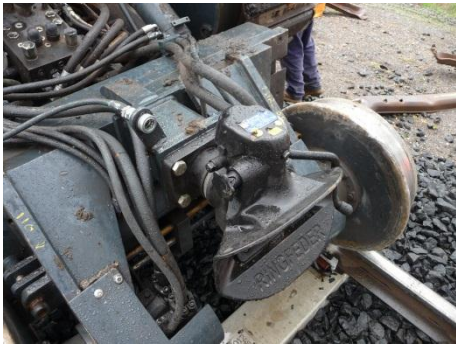
The coupling between the excavator and trailer was a "Ringfeder" type typically found on heavy road vehicles. The operator advises preliminary enquiries reveal a size mismatch between the drawbar ring and the Ringfeder pin of approximately 10mm. The pin was therefore not fully engaged in the drawbar ring and only became dislodged when the excavator de-railed when travelling at approximately 5km/h.

Figure 2: Ringfeder type coupler

1. Examine the adequacy of coupling arrangements to prevent unintended parting.
2. Undertake a thorough evaluation of braking systems to ensure vehicles, trailers, trolleys etc. do not enter an un-braked state in the event of separation. Additionally, ensure the vehicle’s brake system will stop and hold the fully loaded vehicle stationary on the ruling grade and in all weather and track

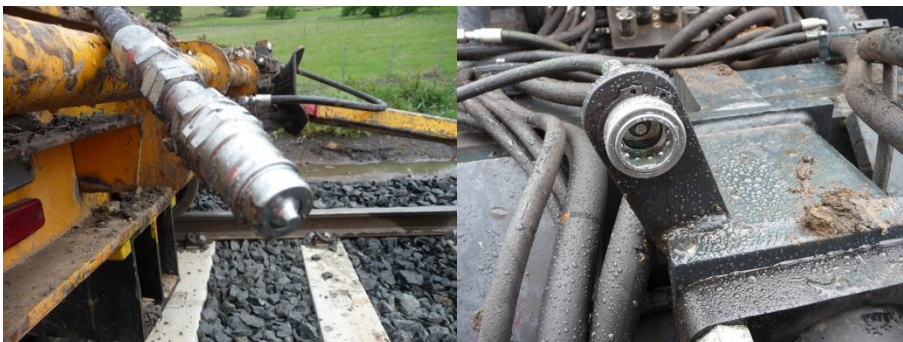
The trailers were fitted with “hydraulic over spring” brakes (meaning hydraulic pressure hold spring brakes in the released position). Brakes are applied by reducing the hydraulic pressure in the brake line allowing the spring to apply brake force to the wheels. The operator controls the vehicle’s speed via the excavator’s normal travel levers which adjusts the hydraulic pressure in the drive motors and brake line according to the desired travel speed.

In this incident, once the trailers became separated from the excavator the hydraulic line separated at the “breakaway coupling”, however the ball (or poppet) valve inside each side of the fittings maintained hydraulic pressure in the trailer’s brake line which kept the trailers’ brakes in the released position allowing them to roll away uncontrolled and in an un-braked condition.

The operator advises the excavator should have been fitted with a locking hydraulic coupling (not the “breakaway coupling” as found on the machine at the time of the incident), so that the flexible hydraulic hose would tear, lose hydraulic pressure and apply the brakes in the event of separation. Both types of fitting are identical in appearance, the difference only detectable in the way they are engaged. The operator is currently investigating why the incorrect fitting was used on this machine.

It is noted that the correct functioning of such arrangement would cause the spillage of hydraulic fluid.

Figure 3 and 4: Hydraulic coupling

3. Assess whether the use of hydraulic braking equipment, causing a spillage in case of separation is acceptable.
4. Ensure equipment new to their operation (including that provided by contractors and/or sub-contractors) is comprehensively assessed, tested and commissioned by a suitably qualified and competent person to ensure compatibility with other equipment it may be coupled to.
