Safety Alert

ARTC No. 80
Issued 12/11/2015

Loose Wheel Nuts on ARTC Vehicles

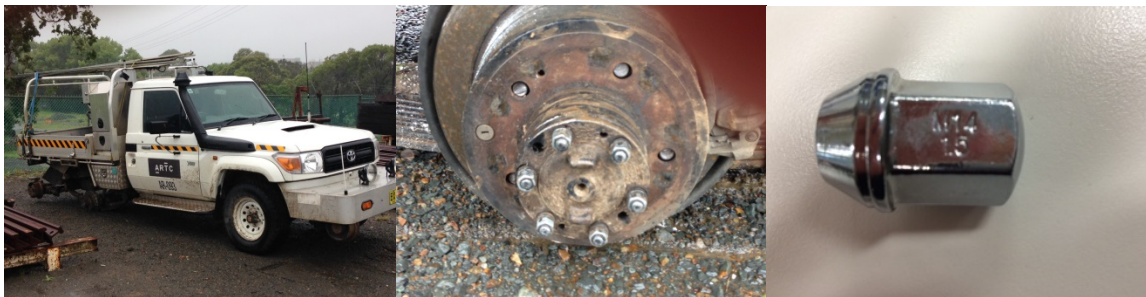
This alert has been issued following an incident where an ARTC motor vehicle wheel stud snapped causing the wheel to come off the vehicle. The vehicle was travelling approximately 105 km/h on a busy highway, fortunately no-one was injured but the incident has caused significant damage to the vehicle.

Further checks of the provisioning centre vehicles have found a number of loose wheel nuts.

Please arrange to have wheel nuts checked on all vehicles based at your provisioning centre and / or also on the vehicle you are driving. As the checks found loose wheel nuts on a number of different vehicles, this safety alert is not limited to Toyota Landcruisers but applies to all vehicles.

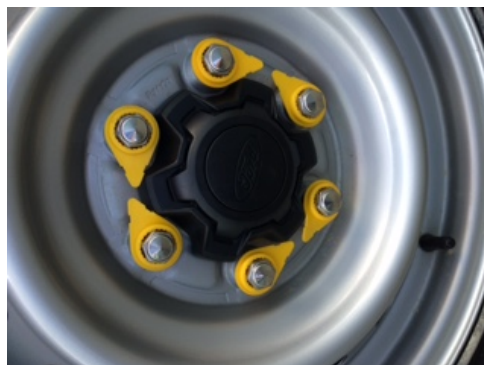
- Drivers are reminded to visually check the vehicle tyres on a daily basis as part of their daily prestart check.
- Drivers are reminded to check their tyre pressure at least monthly or prior to any long trips
- All drivers of light commercial vehicles are reminded to carry out visual checks on the tightness of the wheel nut by location of the wheel nut indicators (where fitted) at least on a weekly basis (see below photo).
- All drivers of heavy vehicles over 4.5 tonne are reminded to carry out visual checks on the tightness of the wheel nut by location of the wheel nut indicators (where fitted) on a daily basis (see below photo).

- All drivers are to ensure that the correct wheel nut is used – the above right wheel nut is to be used with all King Rims (white rims as above left). If it is found that the current wheel nuts are different to the nut shown, they are to be changed ASAP. Please consult with your local tyre supplier or contact Ian Newton, Fleet Manager, to discuss.
- ARTC has instructed suppliers that all small and large vehicles will be fitted with wheel nut indicators either prior delivery of new vehicles or upon routine servicing of existing vehicles
- ARTC Plant Coordinators have been instructed to fit indicators on vehicles that do not have indicators fitted during provisioning centre visits.
- ARTC will distribute to Provisioning Centres indicators for fitting by teams or to expedite, Provisioning Centres are to source locally.
