**ARTC**

**SJ23-0631-RPT-V1**

**Benalla Signal Hut  
Building Inspection Report**

**1<sup>st</sup> September 2023**

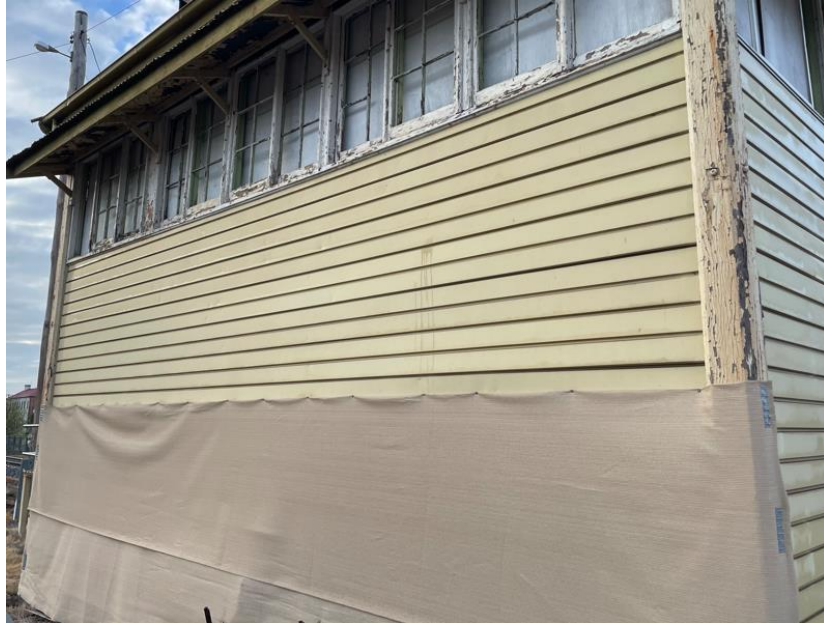
- The building's north-west corner and northern elevation sustained significant structural damage resulting from an assumed accidental vehicle impact collision. This damage included the failure of one of the four timber columns and the internal wall timber members on the northern side. Consequently, a specific section of the first floor was left cantilevering due to the severity of the impact;

*Figure 3-4A – Benalla Signal Hut (North West Corner)*

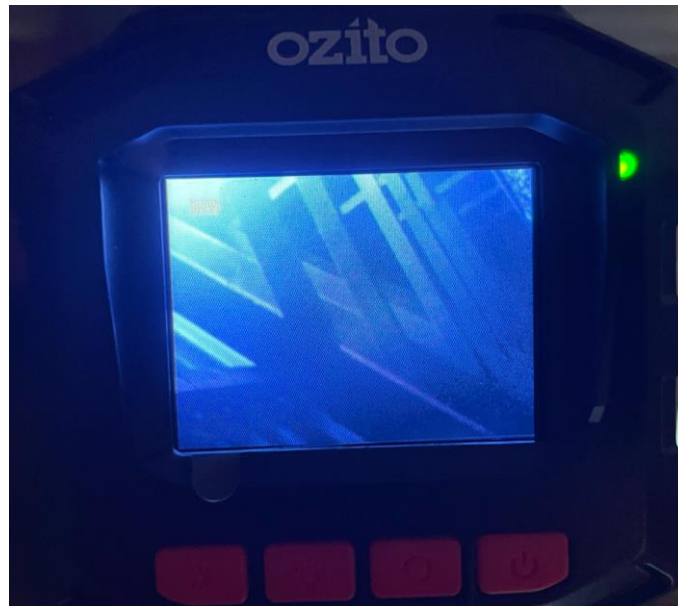
A visual inspection of the timber roof structure was not possible due to a timber ceiling been in place above the first floor. To facilitate some form of visual inspection, holes were drilled in the ceiling, and a cable with a camera attached to the end was fed through the holes. The images obtained from this device revealed that the structural form of the roof consisted of closely spaced timber trusses, supporting timber purlins, which in turn supported the corrugated steel roof sheeting. From the limited observation through the camera device, the timber trusses appeared to be in fair condition. However, due to the restricted access, a comprehensive assessment of the roof's structural integrity could not be conducted.

Figure 3-7: Image of closely spaced timber roof trusses on device

It is theoretically possible to remove the timber trusses and extract the salvageable portions for re-purposing and discard the non-salvageable elements.

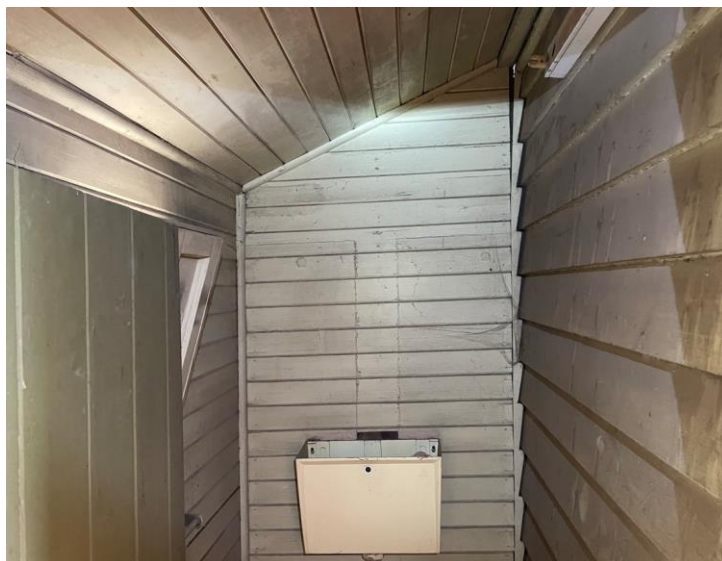
Figure 3-28: Timber walls for first floor toilet

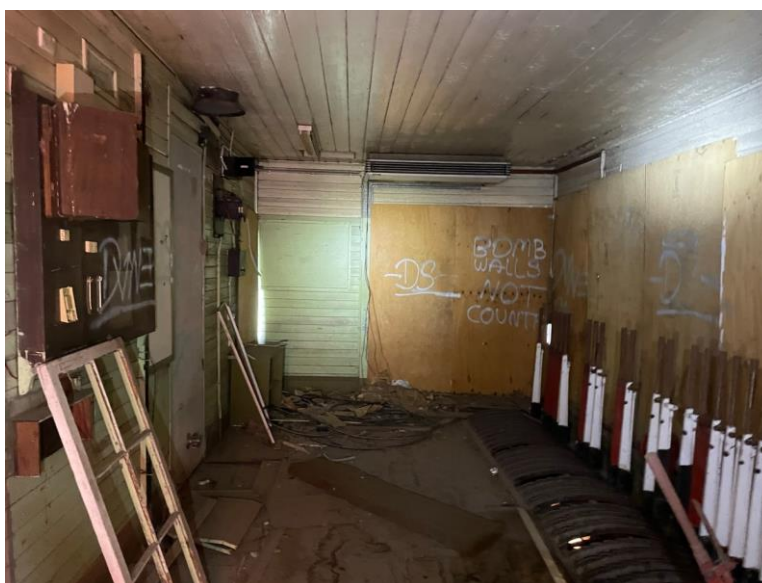
Figure 3-29: First floor Operating Room

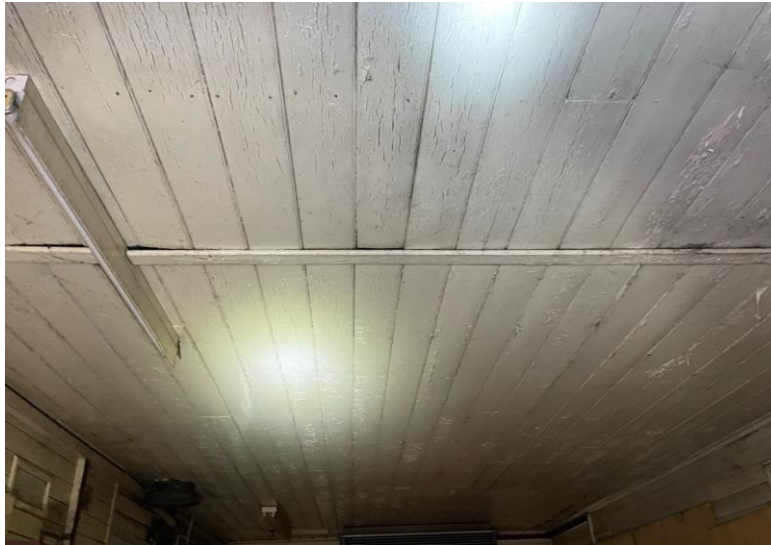
*Figure 3-30: timber ceiling to first floor*

It is theoretically possible to remove the internal timber flooring and ceiling from the signal hut, and extract the solid portions of timber for re-purposing and discard the weakened and/or rotten elements.

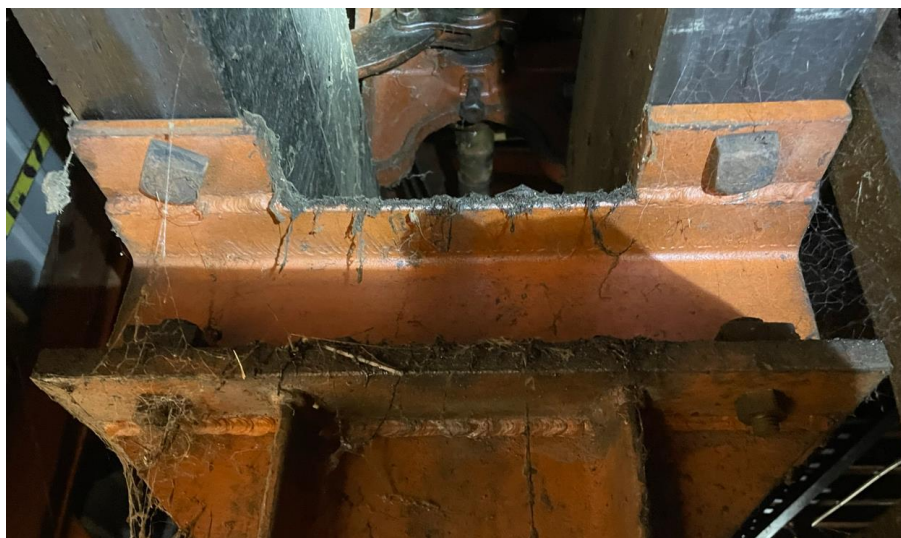
*Figure 3-40: Internal steel lever frame supporting first floor elements*
