Safety Alert

ARTC No. 114
Issued 06/09/2019

Rail Clamps

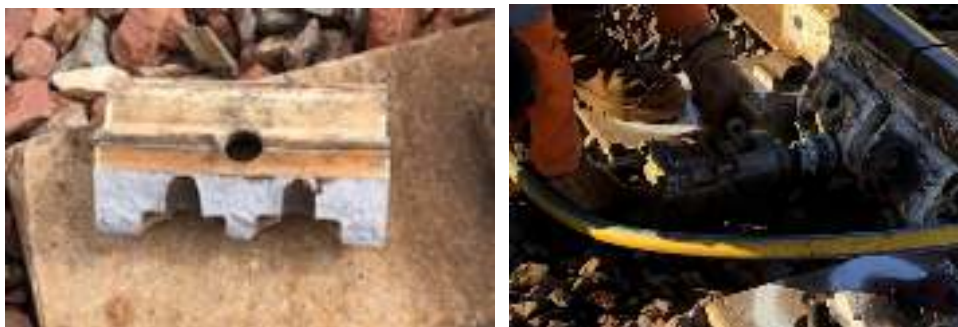
This alert has been issued following an incident where a Rail Clamp whilst being tightened, sheared in two and flew up striking a worker in the face. The worker sustained a broken nose and a hairline fracture to his jaw.

The Rail Clamp was being installed using a rattle gun to tighten the hexagonal nuts. The 'Installation and Operating Instructions for Robel Clamps' attached to this alert, require the hexagonal nuts to be tightened using a suitable tool (e.g. torque wrench) to a torque value of 580Nm.

- All Rail Clamps are inspected for signs of metal fatigue and/or stress fractures. If found, these Rail Clamps are to be disposed of immediately.
- Hexagonal nuts are to be tightened with a suitable tool (e.g. torque wrench) to a torque value of 580nm as per the attached manufacturer's installation and operating instructions.
- All workers using Rail Clamps are to re-familiarise themselves with the attached 'Installation and Operating Instructions for Robel Clamps'
