Safety Alert

ARTC No. 109
Issued 24/08/2018

Tamper collision with ARTC vehicle

Tamper collides with an ARTC light vehicle at a passive level crossing

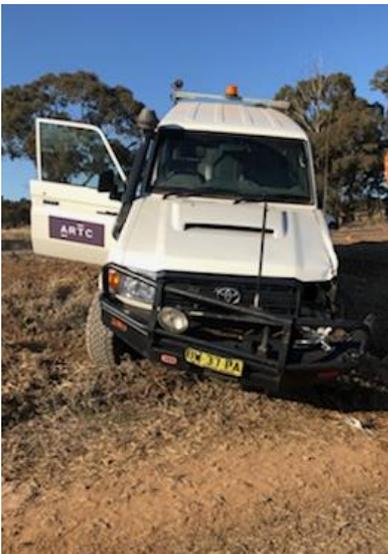
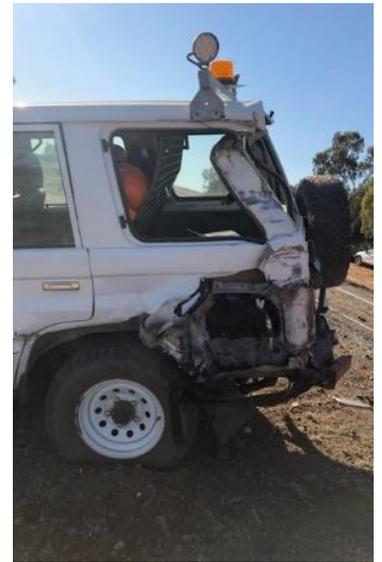
This alert has been issued following a high potential incident where an ARTC vehicle navigating a passive level crossing was severely damaged after colliding with an ARTC tamper. There were no reported injuries as a result of the collision.

The ARTC Tamper and Regulator were supporting re-sleeping operations, travelling between worksites within the limits of a Track Occupancy Authority and separated by a distance of 800 metres. There was a 20km/h Temporary Speed Restriction in force at the crossing at the time of the incident due to the reduced sighting distance available.

The driver of the road vehicle stopped at the stop sign and then proceeded over the crossing. Speed information obtained from the machines indicates that the Regulator and the Tamper were travelling faster than the Temporary Speed Restriction at the time of the collision.

This incident highlights the importance of identifying the location of and adhering to temporary speed restrictions within the network. **Any operators of rail bound vehicles including track machines and any Road Rail plant/vehicles, must adhere to all Temporary Speed Restrictions that are located within their worksite or path for travel.**
