Safety Alert

ARTC No. 88
Issued 21/07/2016

Concrete Burns

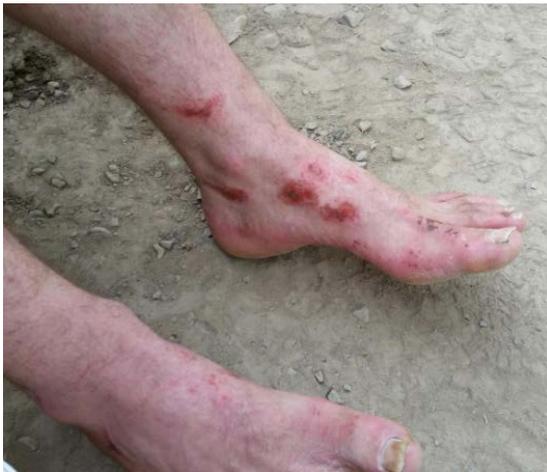
Worker 2 injury - one day after exposure

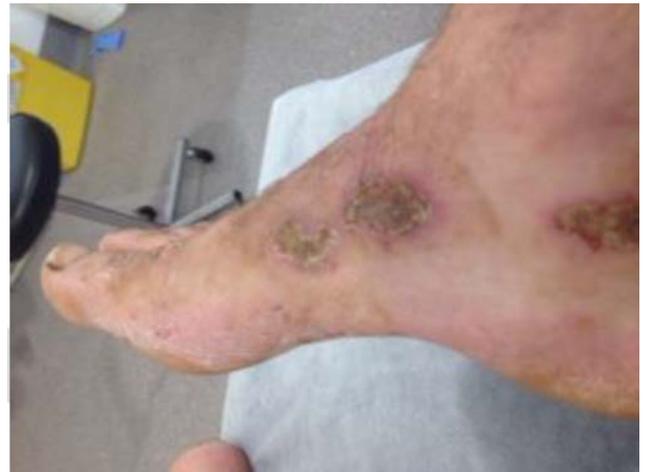
Worker 2 injury - five days after exposure

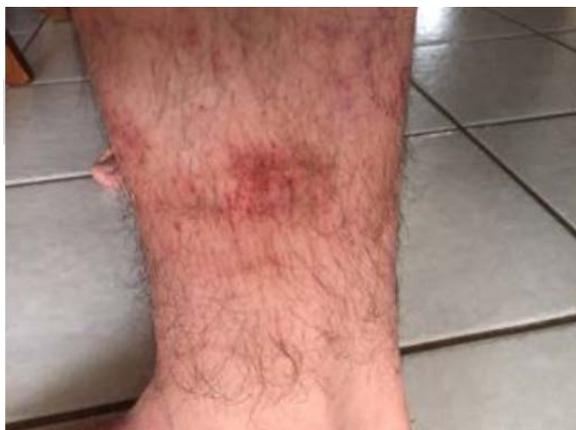
Worker 1 injury - one day after exposure

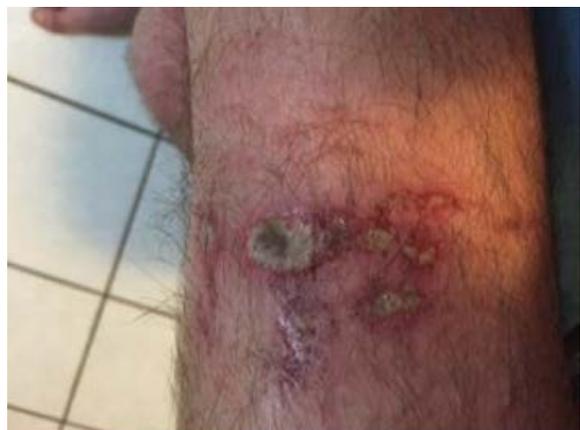
Worker 1 injury - four days after exposure
