# Safety Alert

ARTC No. 96  
Issued 10/05/2017

## Isuzu Truck Cabin Mount Failure

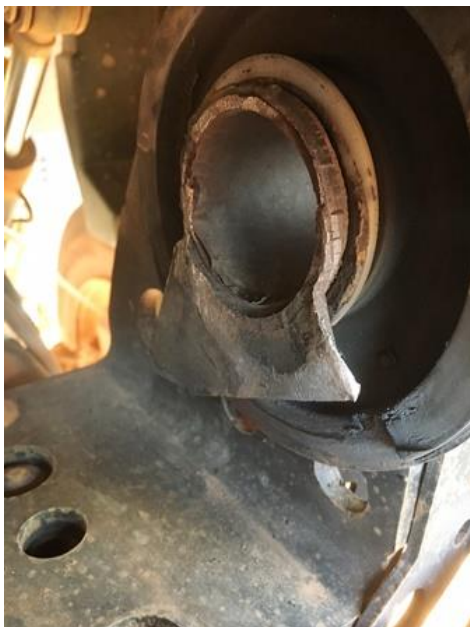
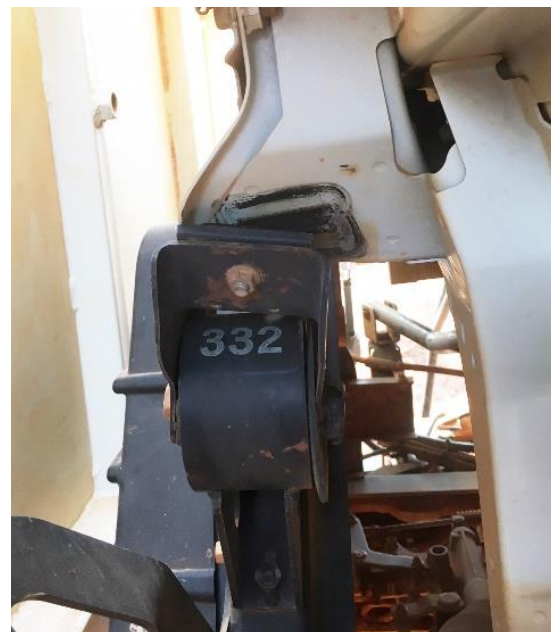
This alert has been issued following an incident where an Isuzu FTS800 Gang Truck suffered complete failure of the main cabin mounts resulting in the cabin becoming detached from the truck chassis. Whilst no personnel were injured, the potential for this incident to cause severe injury in the event this vehicle was involved in a frontal impact incident is extremely high.

1. Immediately visually inspect front cab pivot mounts and rear support mounts on any similar trucks in your area of control for signs of cracks, deformation or deterioration of these components.

2. Each truck of this class must be inspected by a qualified Isuzu service agent to determine if any similar defects are present. Individual Area Managers will be contacted to arrange this.
