# Significant Safety & Health Incident Alert

## Worker injured with backhoe bucket

<b>Alert No.</b>	146		
<b>Date</b>	8 December 2010	<b>Division</b>	Construction
<b>Site</b>	RAAF Tindal Q1314	<b>Business Unit</b>	Northern Region
<b>Energy type</b>	Vehicular	<b>(Potential) Damage</b>	Class 1 (Actual Class 2)
<b>Contact details</b>	Name John Ballard - Phone 0418 637309 Email john.ballard@leicon.com.au

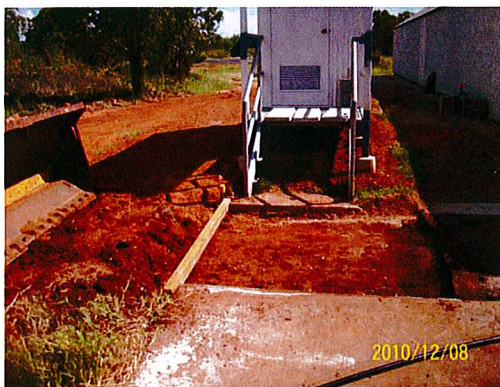
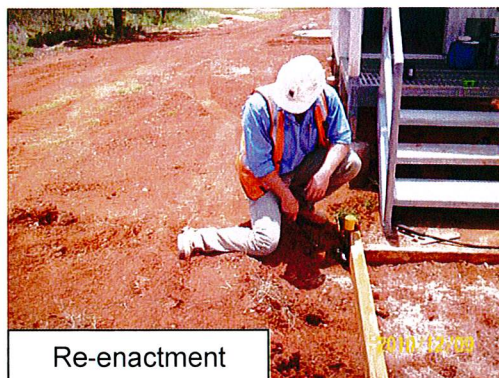
Sub contractor three man crew preparing 1.5msq footpath pad for concreting. Loose spoil from pad preparation was back spread with a backhoe in reverse (approx 2m distance). Worker two commenced the boxing activity and worker three walked away to a nearby work truck. The operator drove forward and lowered the bucket to the ground connecting with the right ankle of worker two resulting in a fractured right fibula. Early investigation indicates backhoe operator thought worker two had walked away to the truck parked nearby. Worker three was in fact that person. Operator had lost sight of worker two while spreading in reverse and failed to see him fixing the boxing due to the suspended backhoe bucket.

- Workers are not permitted to work in and around operating mobile plant.
- Where there is any doubt a ground worker could come in contact with mobile plant, the plant is to be shut down until clear separation can be established.
- Where there is plant and personnel operating in close proximity, subcontractor operations should have a supervisor appointed to monitor that activity.
