# SAFETY BULLETIN

Issued: 25 March 2013  
Expiry: 25 June 2013  
Number PRJ-BUL-06-2013

## Missing Spreader Bar on Twin Lid Pit

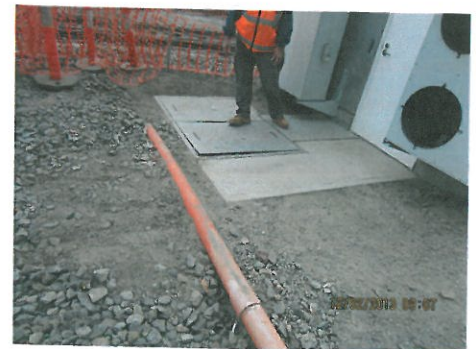
During the occupation of VS2 (Viaduct Stage 2), an MTM employee stepped on a Steel lid of a Signalling AV & Comms. Pit causing it to give way, and fell 1.5 metre into the Pit.

Employee was In the process of moving material from area adjacent to the running track and moved across the area of the pit. When weight was placed on the pit lid it gave way as the Spreader Bar was not in place.

It appears that on installation of these pits, either the Spreader Bar was not fitted, or the bar was removed for ease of access and not reinstated during Cabling Works. It seems there has been no follow up after works were completed on the pits to ensure that the Spreader Bar was replaced, the pit lids were undamaged and were sitting correctly in the flange according.

Inspection of dual pit lids to ensure that Spreader Bar/s are correctly fitted within each pit/s.
