ARTC No. 68

## Accessing Truck Platforms

### Incident

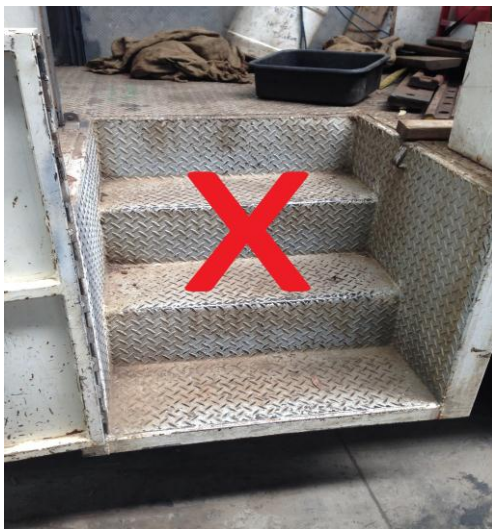
Recently, one of our workers fell from a truck platform as he was about to descend the access stairwell on a work vehicle. He suffered a fractured lower arm that required surgery and plating.

The stairs (pictured on left) did not have non slip edging or hand rails fitted.

In order to avoid these injuries, it is important to understand the 3-points of contact rule. Stated quite simply, always keep three points of contact whilst entering/exiting & climbing stairwells. Handrails are required to be in place to enable you to have 3 points of contact.

Everyone is asked to check your vehicles with stairwells for:

- Non slip steps in good condition
- A handrail is installed that can be used whilst accessing the stairwell

Immediately report any deficiencies to your Manager.
