Victorian Interstate Infrastructure Lease KPI Report
3rd Quarter 2018/2019 (Jan-Mar)

In accordance with the Victorian Interstate Infrastructure Lease, this document presents the KPI Report under the lease covering the period January 2019 to March 2019.

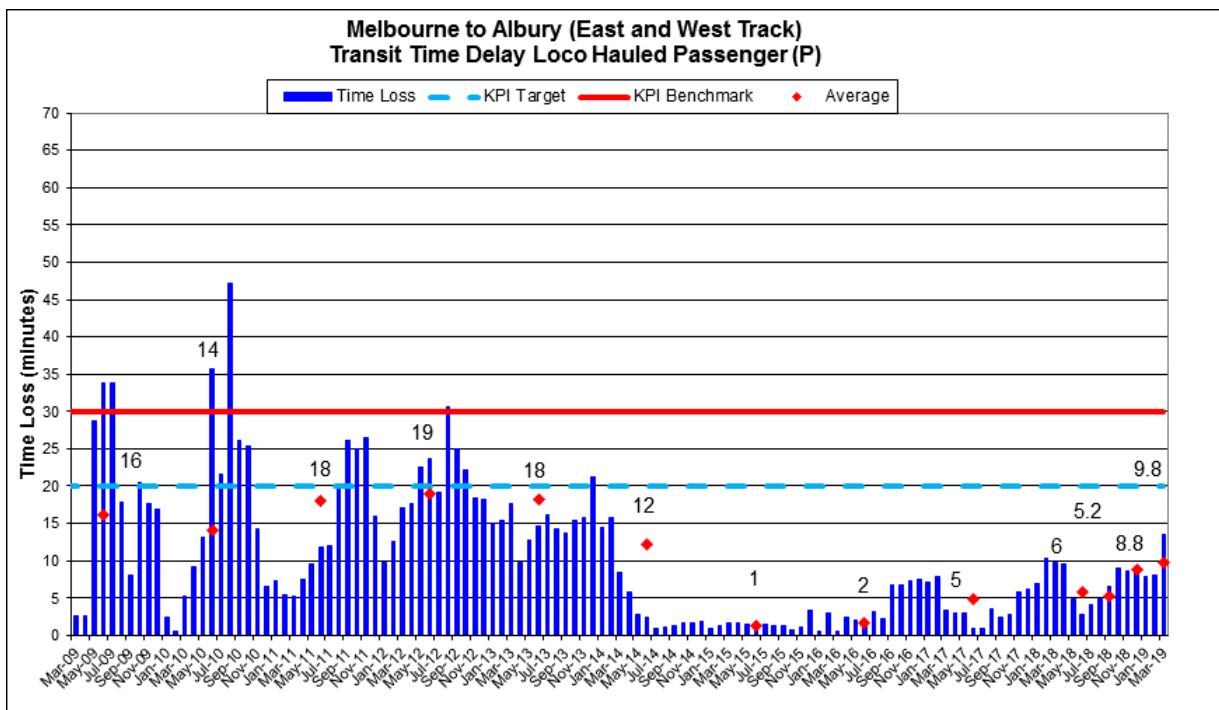
Figure 3: Melbourne to Albury Transit Time Delay for Loco Hauled Passenger trains

Figures 3-9 show the longer term trends for time loss due to temporary speed restrictions in each KPI Region.

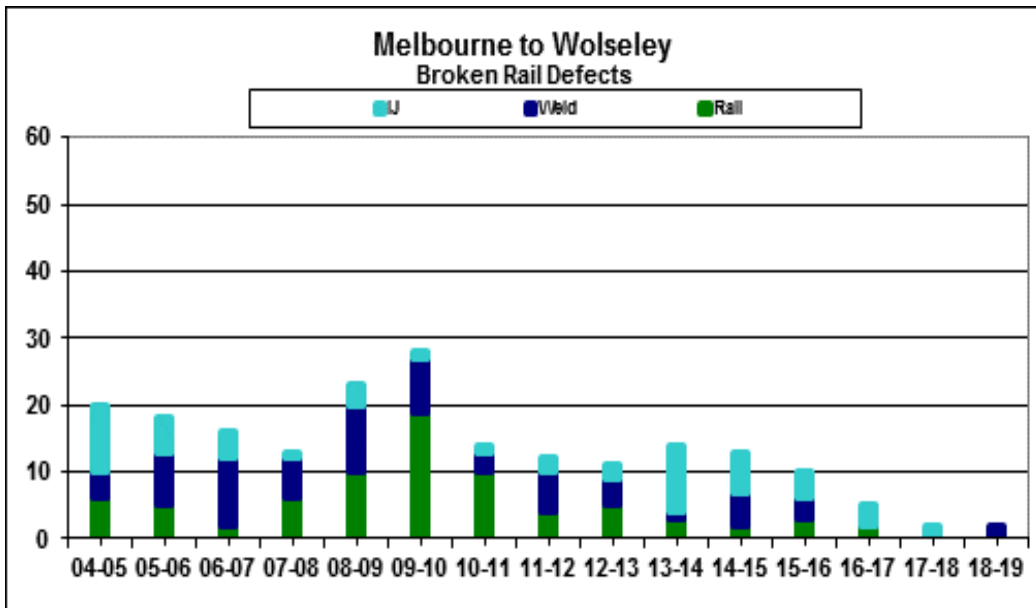
The broken rail data provided below includes details of broken rails, broken welds and broken insulated rail joints for each KPI Region.
